Jones & Henry Engineers, Ltd. 3103 Executive Parkway, Suite 300, Toledo, OH 43606

Raw Water Main Route

Study Objectives

- Review previous condition assessment reports
- Develop recommendations for repair or replacement of 78-inch raw water main

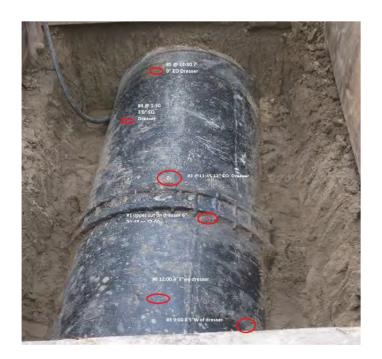
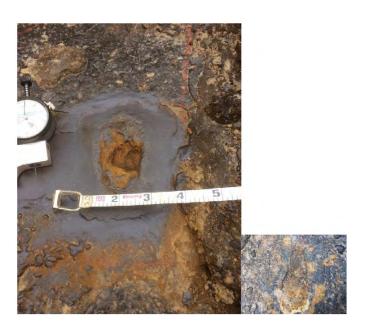
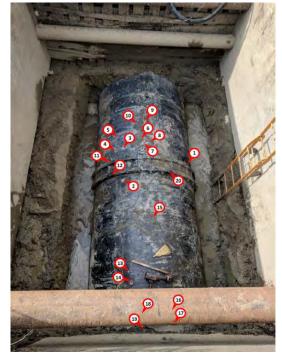
- All segments of 78-inch raw water main require repair or replacement
- Leaks are likely to occur with increasing frequency

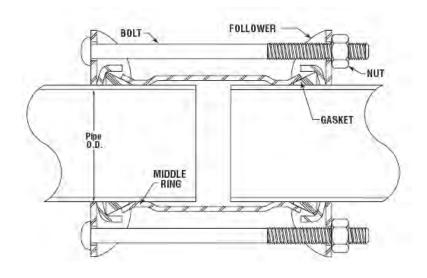
- All segments of 78-inch raw water main require repair or replacement
- Failure of 'Dresser' coupling (pipe joint) is the most catastrophic risk to pipeline
