## Investigation Report

Published: June 2024

## U.S. Chemical Safety and Hazard Investigation Board

The September 20, 2022, naphtha release and fire at the BP-Husky Toledo Refinery fatally injured two employees, who were brothers:

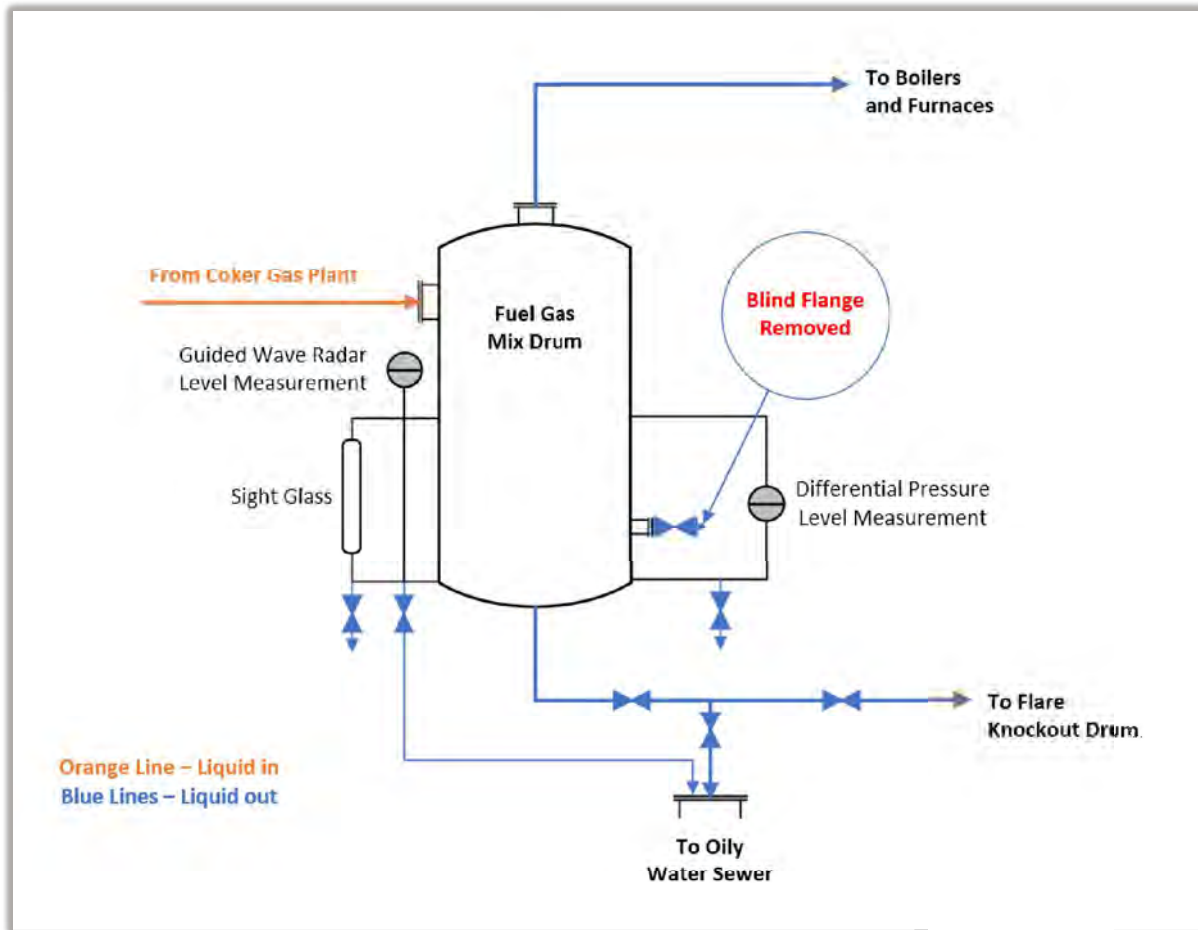
<sup>c</sup> This valve on the side of the Fuel Gas Mix Drum was only intended for access by maintenance as part of turnaround or maintenance activities.

**Figure 10:** Fuel Gas Mix Drum during overfill and attempted emptying. Liquid exit locations are shown in blue. (Credit: CSB)

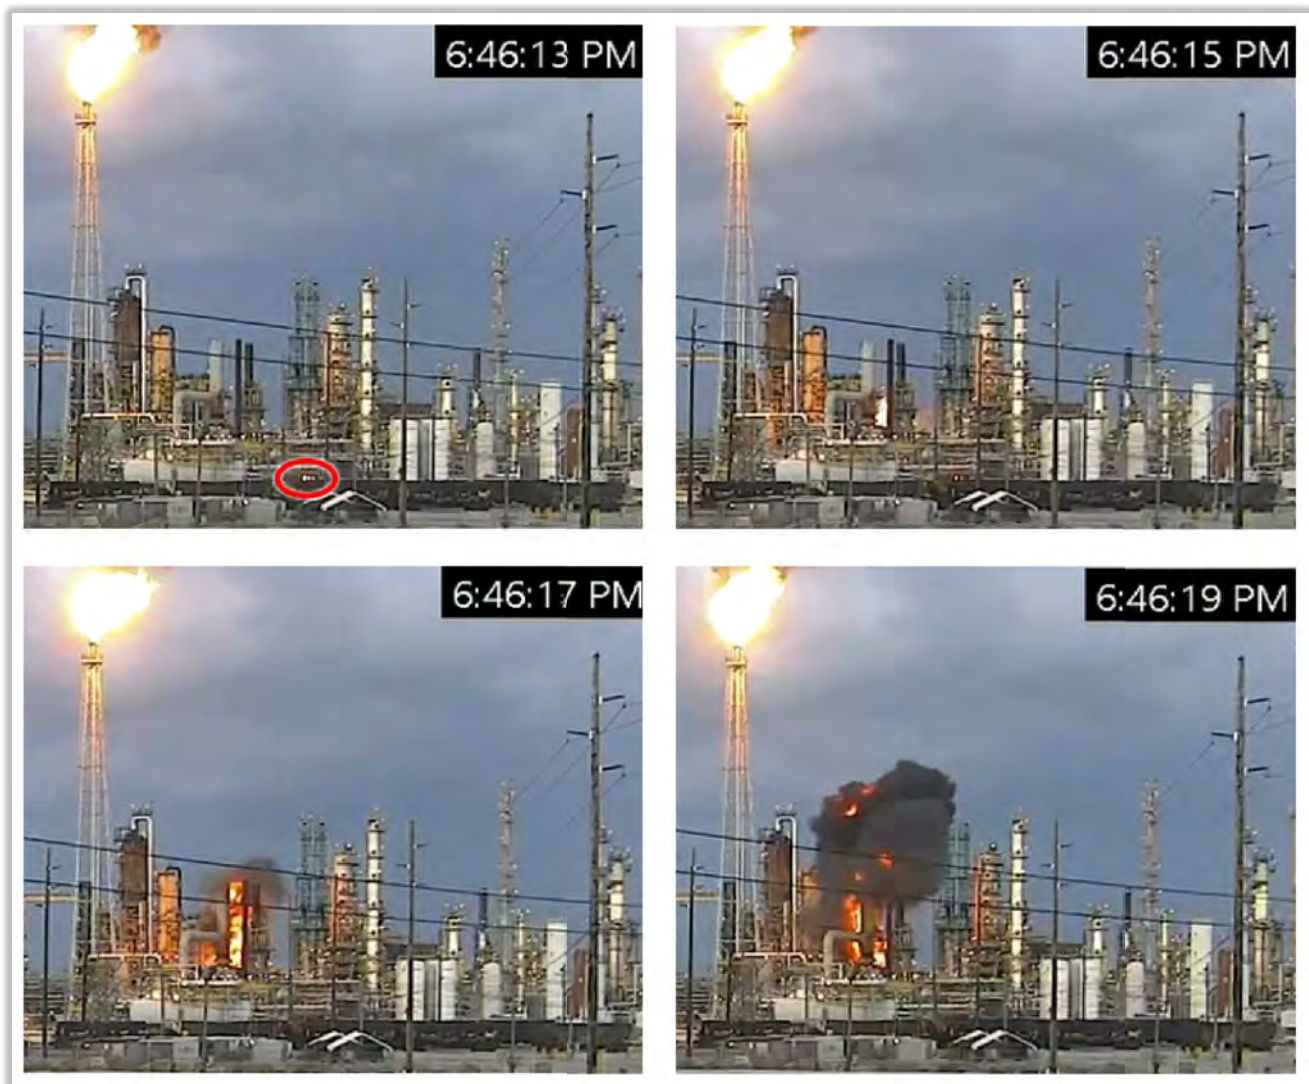
An approaching rainstorm shifted the wind, which likely directed the vapor cloud toward the nearby Crude 1 Furnace, the likely ignition source. The vapor cloud ignited at 6:46 p.m., as shown in **Figure 11**. **Figure 12** shows the Crude 1 Furnace's proximity to the Fuel Gas Mix Drum, the area of the naphtha release, and the eyewitness's location.

**Figure 11:** Vapor cloud ignition and the ensuing six seconds. Ignition at Crude Furnace (circled in red, upper left photo). (Credit: BP with annotations by CSB)

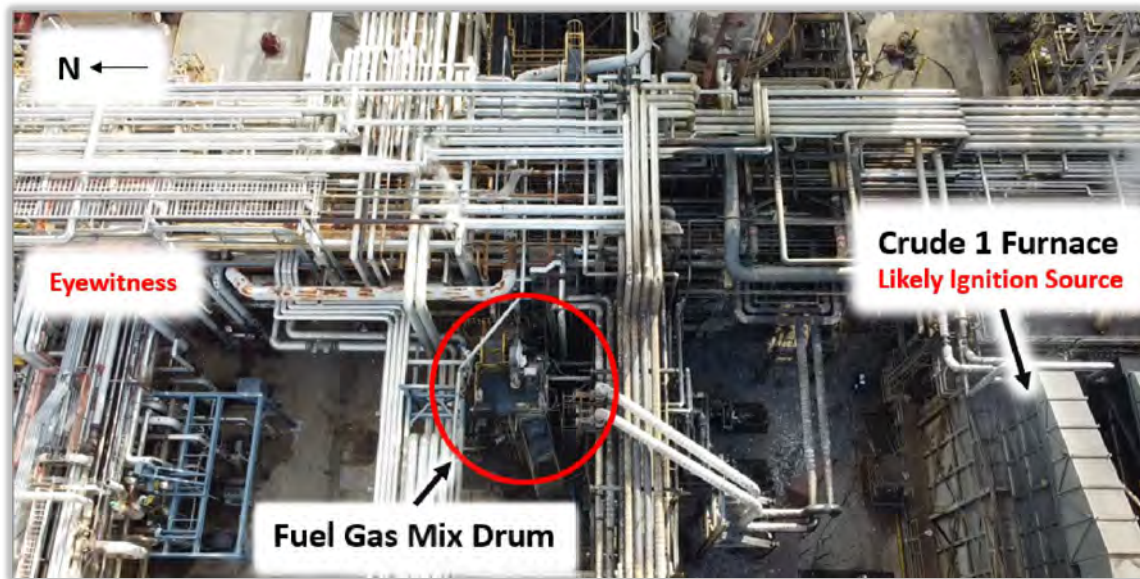
**Figure 12:** Overhead view of naphtha release, likely ignition source, and eyewitness location. (Credit: BP with annotations by CSB)

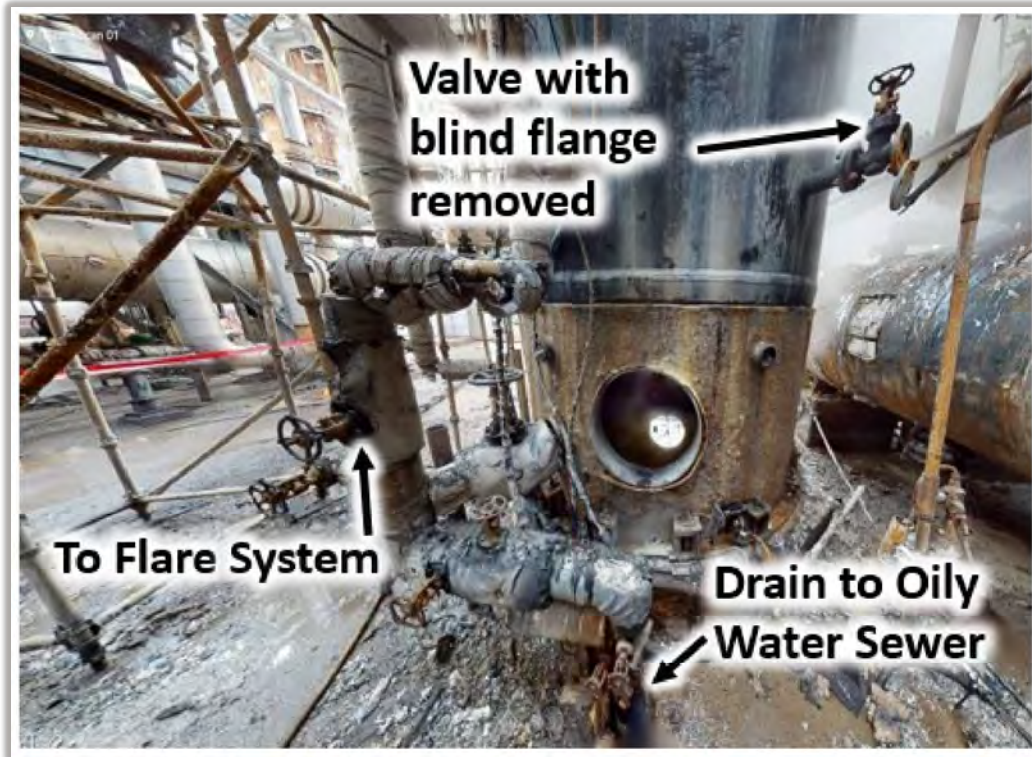
**Figure 13** shows the Fuel Gas Mix Drum after the incident.

**Figure 13:** Fuel Gas Mix Drum post-incident. (Credit: BP with annotations by CSB)

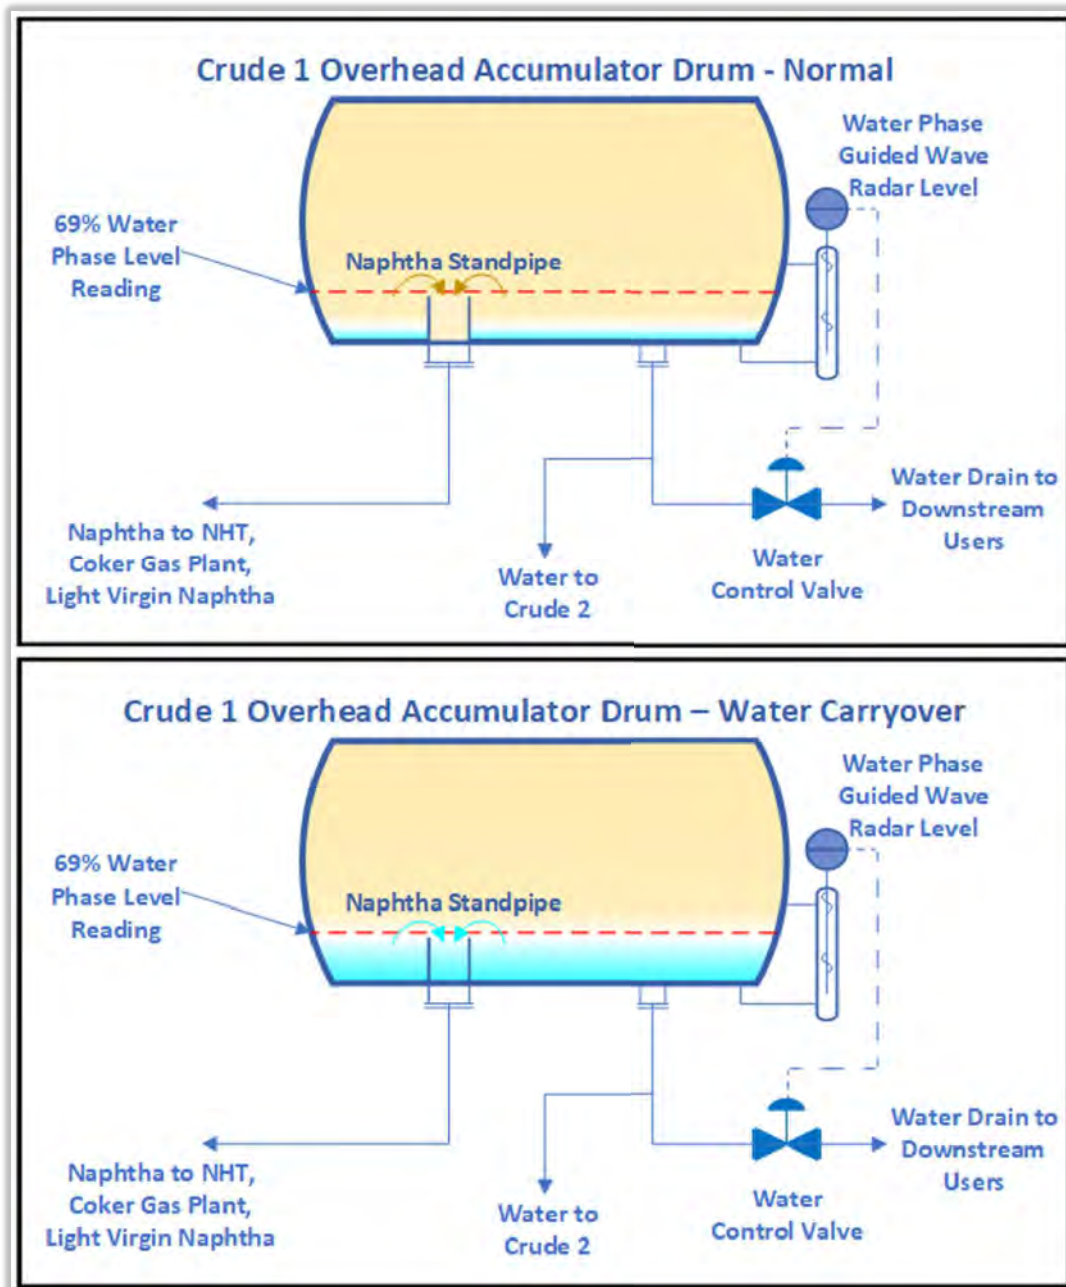
**Figure 14:** Crude 1 Overhead Accumulator Drum water phase level before water control valve adjustment (top) and during water carryover into naphtha stream (bottom). (Credit: CSB)

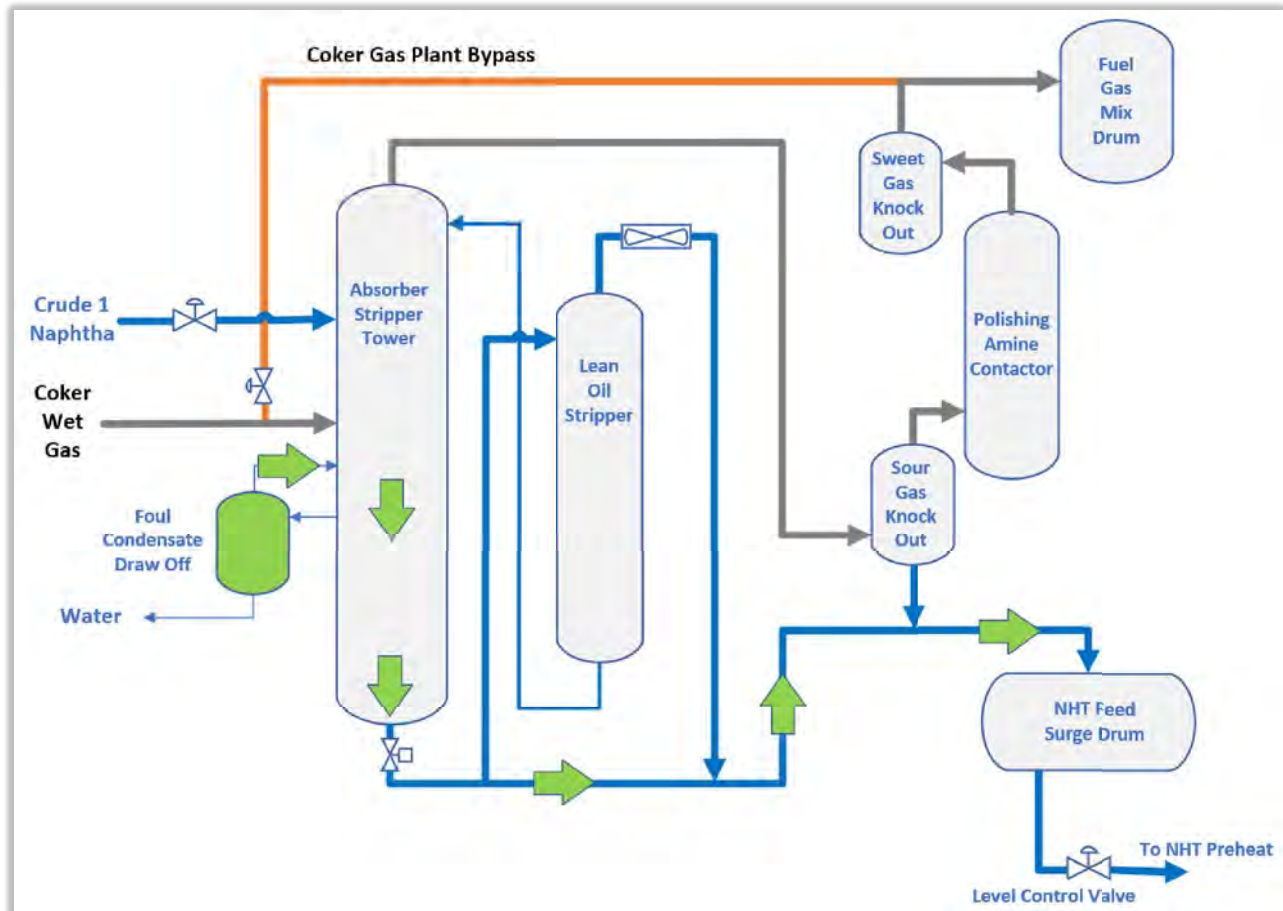
opened to remove the excess level, causing increased liquid level in the NHT Feed Surge Drum. This NHT Feed Surge Drum level increase resulted in higher flow and pressure to NHT Preheat when the NHT Feed Surge Drum level control valve in turn opened further.<sup>a</sup> **Figure 15** shows this water overflow and resulting liquid flow increase out of the Absorber Stripper Tower bottoms and into the NHT Feed Surge Drum.

**Figure 15:** Water overflow in Coker Gas Plant Absorber Stripper Tower and flow increase to NHT Feed Surge Drum (green arrows). (Credit: CSB)

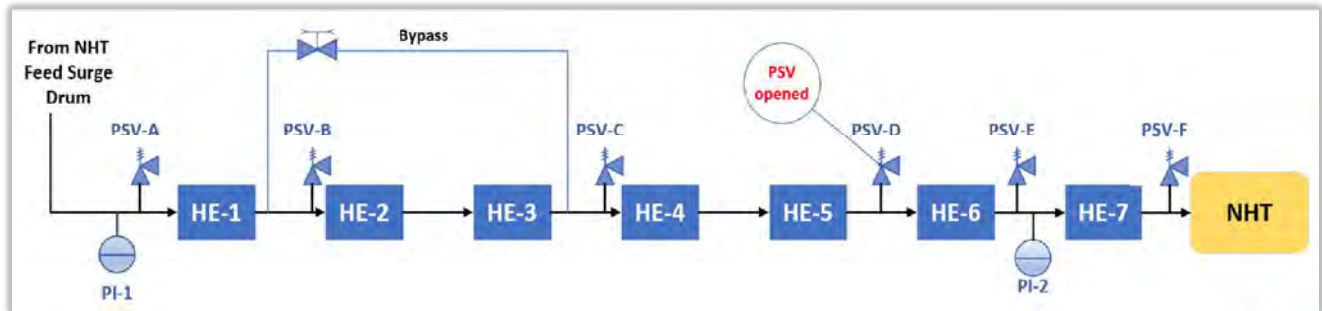
**Figure 16:** Location of first emergency pressure-relief valve (labeled as PSV-D) opening on NHT Preheat heat exchangers (each labeled as HE).<sup>a</sup> (Credit: CSB)

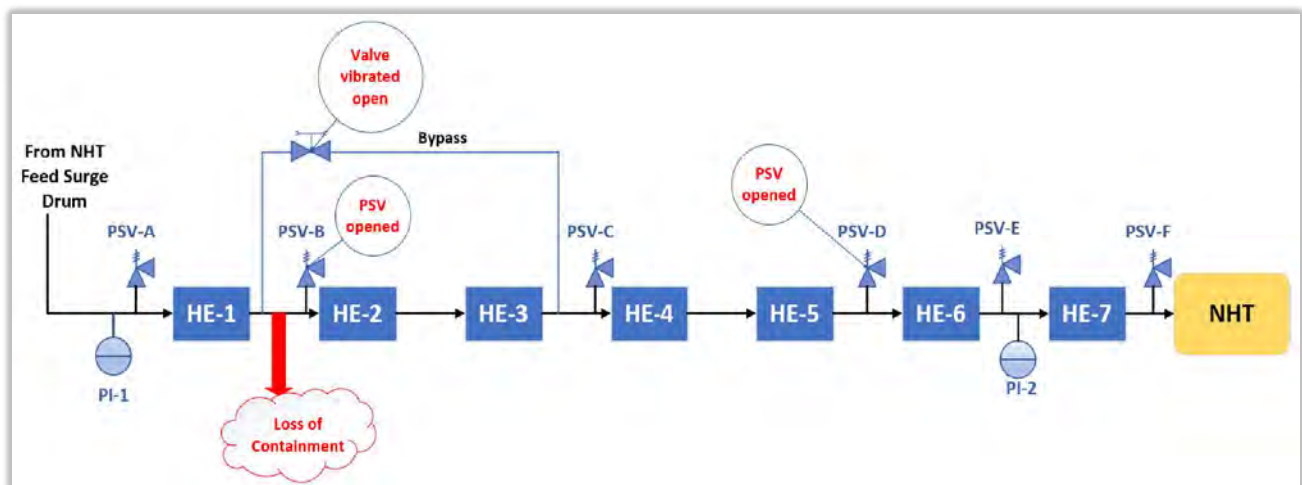
The continuing piping vibration then caused the branch connection to the drain valve to fail completely, and the 3/4-inch bleed broke off at approximately 8:12 a.m., 18 minutes after the first smaller leak began. With this loss of primary containment, the naphtha leak was significantly larger. Operations personnel decided to implement an emergency depressurization and shut down of the NHT unit. **Figure 17** shows the locations of the 3/4-inch bleed failure where the loss of containment occurred, and both emergency pressure-relief valves that opened.

**Figure 17:** NHT Preheat loss of containment and emergency pressure-relief valve (each labeled as PSV) openings at NHT Preheat heat exchangers (each labeled as HE). (Credit: CSB)

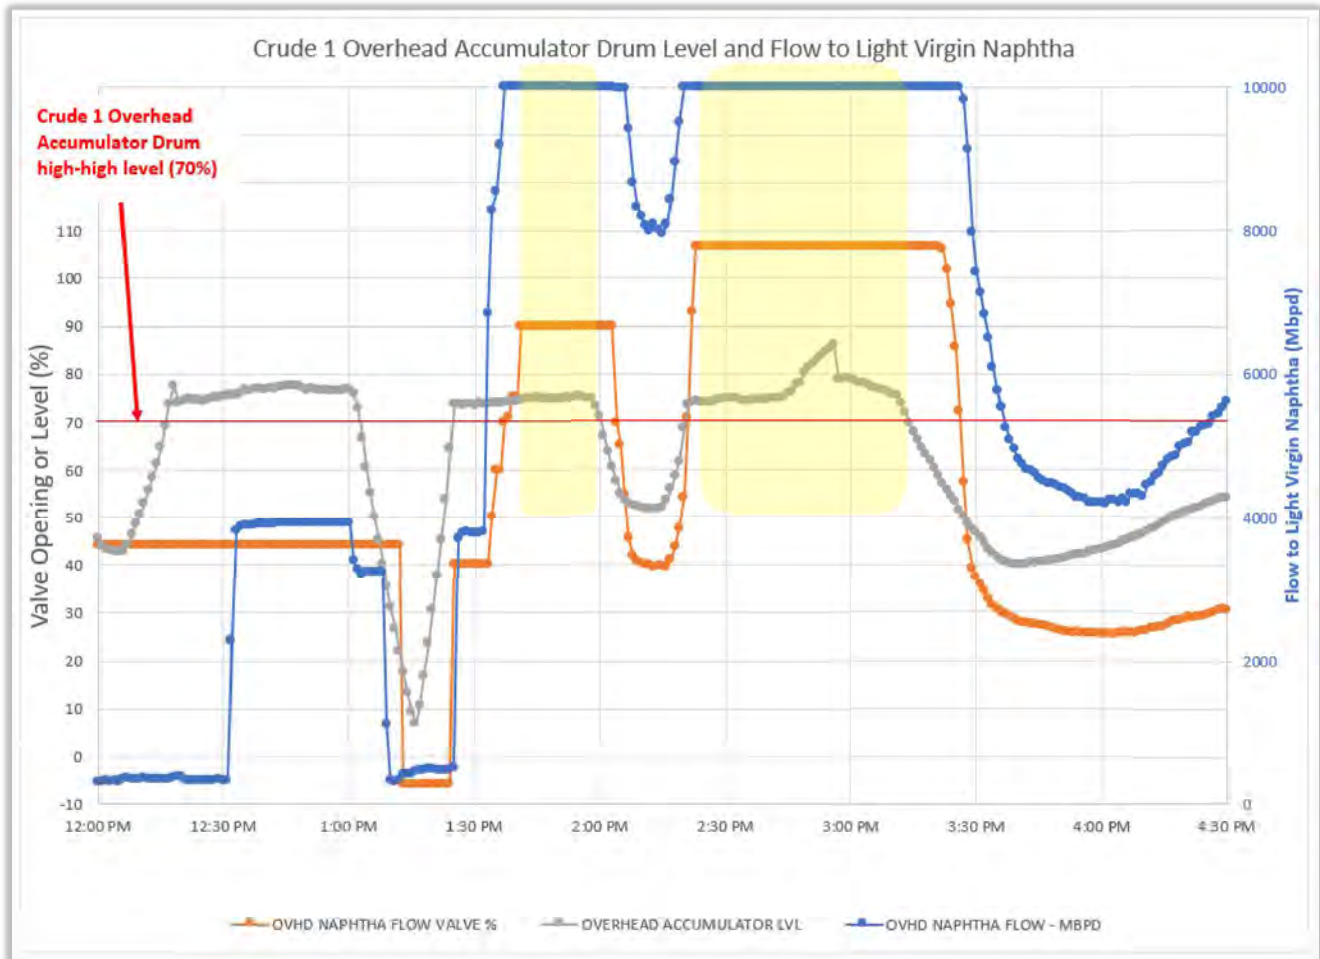
**Figure 20:** Crude 1 Overhead Accumulator Drum level control and flow to Light Virgin Naphtha. The yellow shaded areas indicate periods of accumulator level (gray) over the high-high alarm setpoint, while the flow meter to Light Virgin Naphtha (blue) was out of range and the flow control valve (orange) nearly or fully opened. (Credit: CSB)

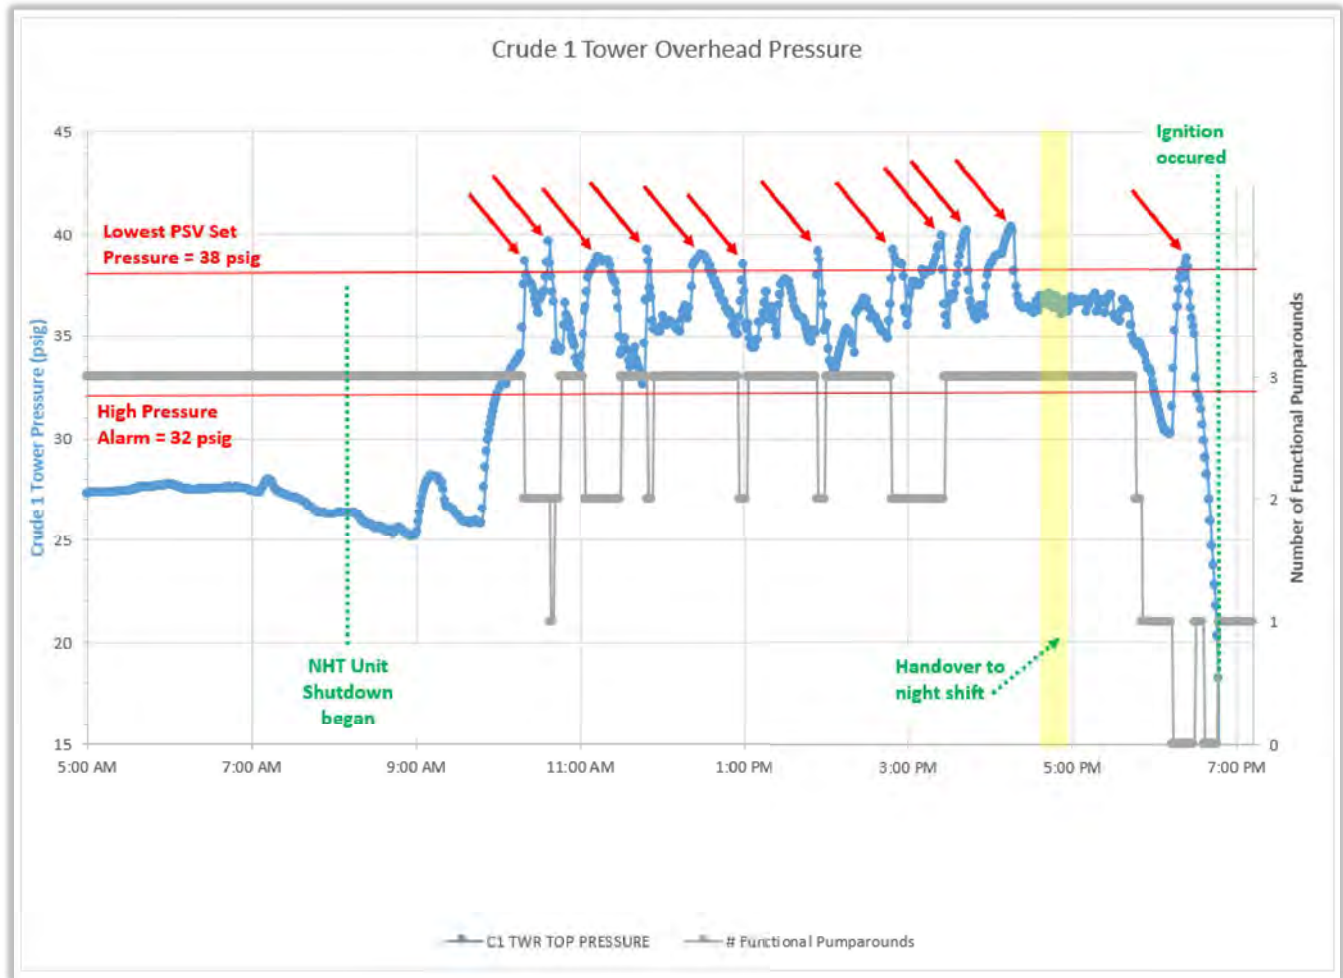
**Figure 21:** Crude 1 Tower overhead pressure. Red arrows indicate likely emergency pressure-relief valve(s) (PSV) opening. Crude 1 Tower pressure (blue trend) was above the high alarm point (32 psig) for much of the day. (Credit: CSB)

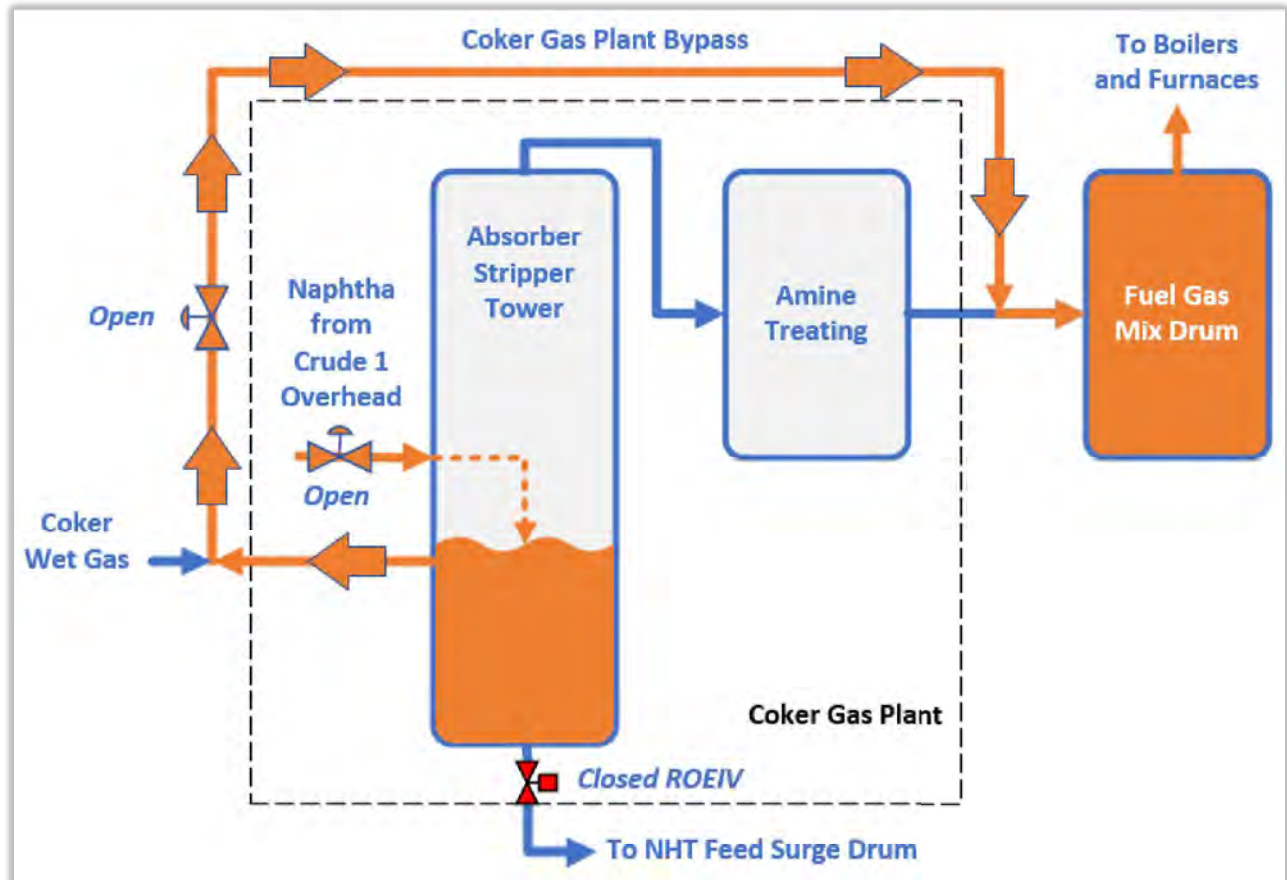
**Figure 26:** Overflow path from Coker Gas Plant to Fuel Gas Mix Drum (orange arrows).<sup>a</sup> (Credit: CSB)

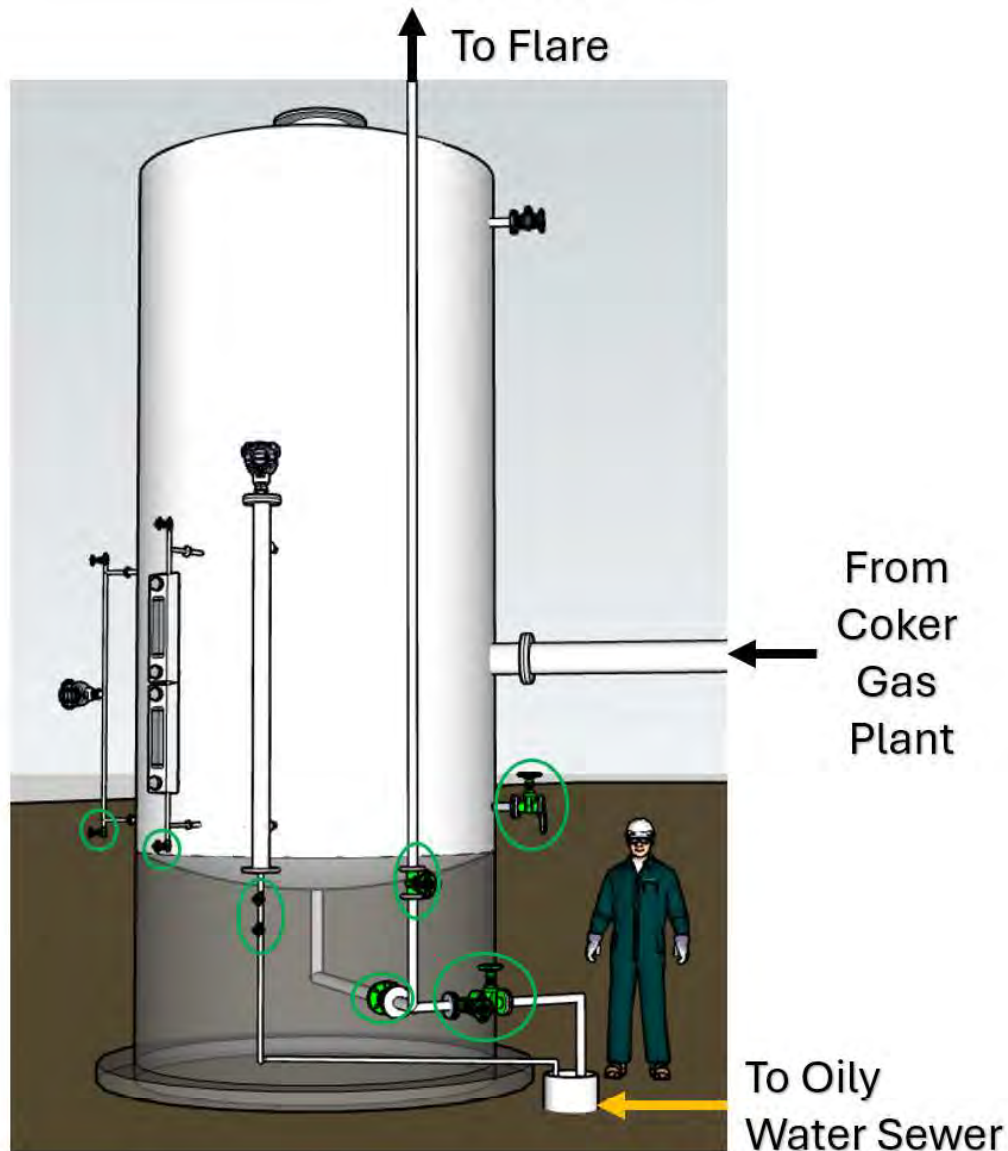
**Figure 28.** BP Toledo Refinery Fuel Gas Mix Drum. Valves circled in green were opened to drain and release naphtha. (Credit: CSB)

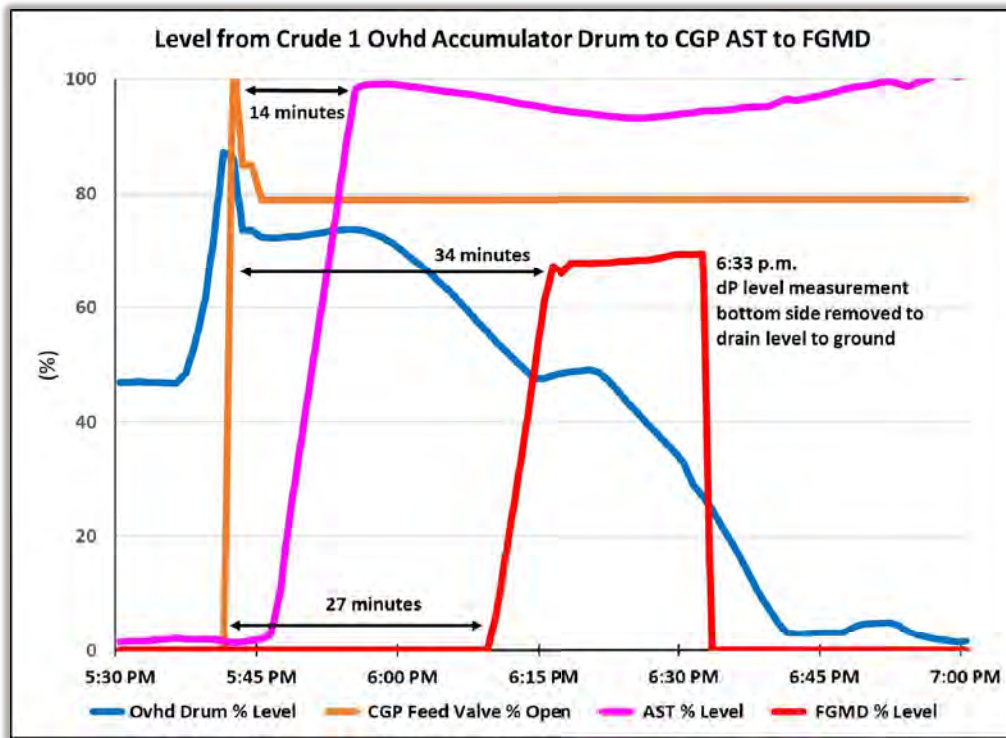
**Figure 29.** Overflow progression. Decreasing level in the Crude 1 Overhead Accumulator Drum and increasing levels in the Coker Gas Plant Absorber Stripper Tower and Fuel Gas Mix Drum.<sup>a</sup> (Credit: CSB)

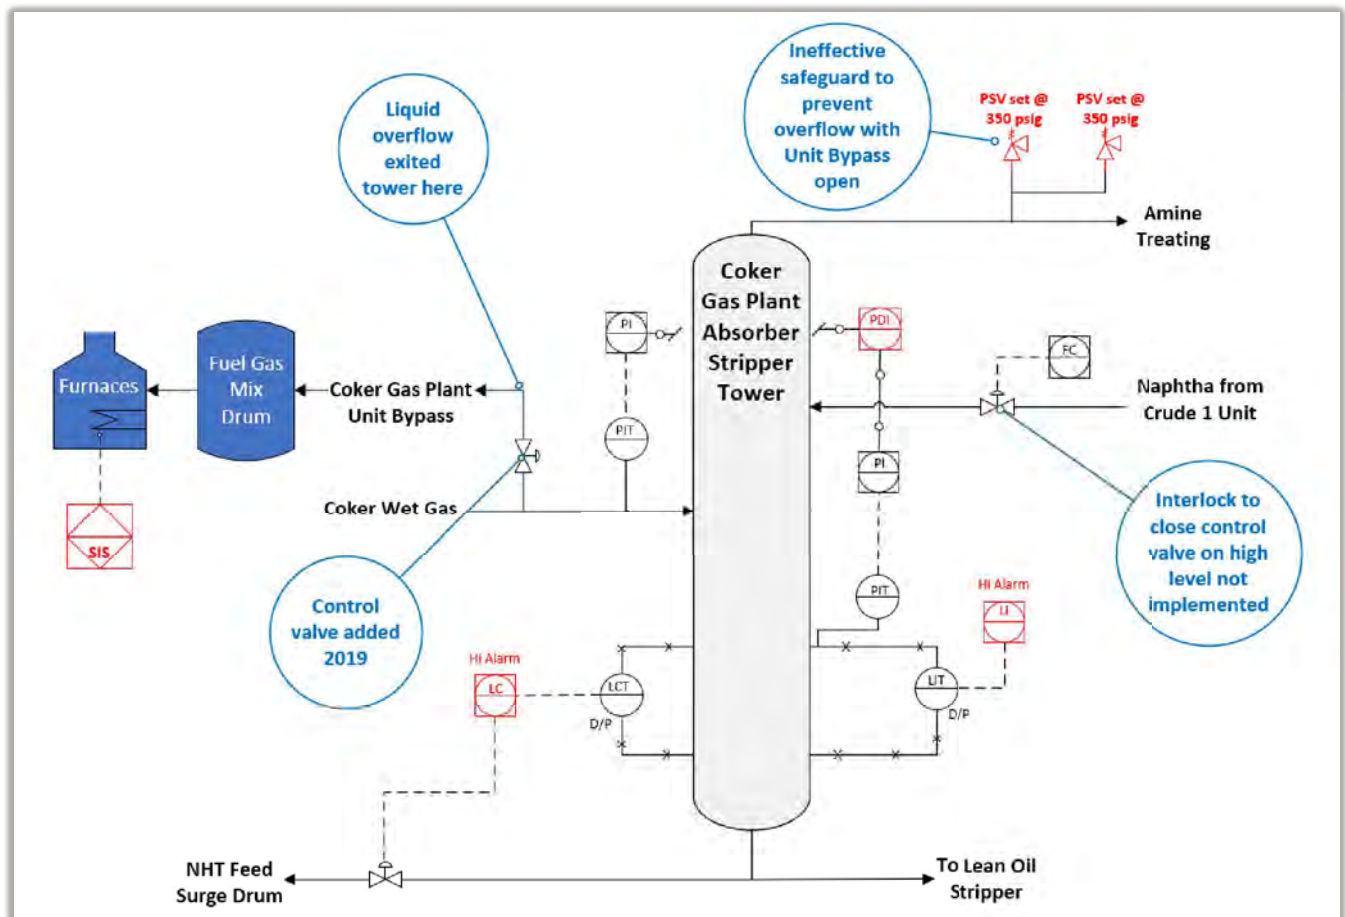
**Figure 30:** Absorber Stripper Tower safeguards identified in the 2020 Coker Gas Plant PHA, shown in red. (Credit: CSB)

Revise the safeguards used in the refinery’s process hazard analyses high level and overflow scenarios. At a minimum, establish effective preventive safeguards that use engineered controls to prevent liquid overfill and do not rely solely on human intervention.

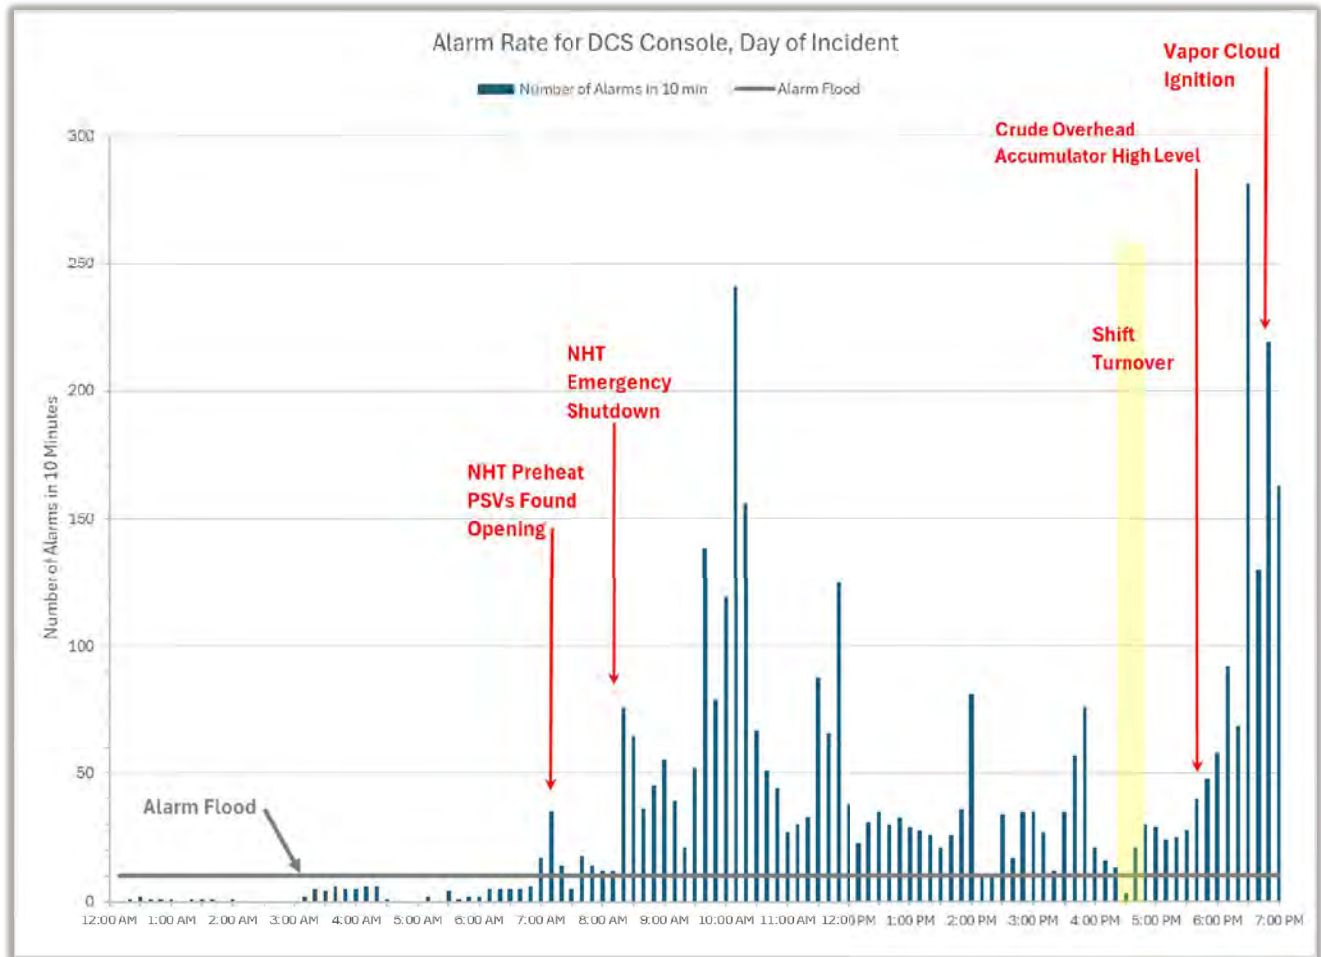
**Figure 36:** DCS console alarm rate on September 20, 2022, with some process events (in red). The gray line indicates alarm flood rate (10 alarms in 10 minutes). (Credit: CSB)

Revise the ‘Toledo Alarm Philosophy’ by incorporating the Engineering Equipment and Manufacturers Users Association (EEMUA) guidance for alarm rate following an upset and not limiting alarm performance to a single metric averaged over a month. In addition to including analyzing individual alarm flood events, the revised philosophy document should improve refinery alarm performance to reduce alarm flood duration and peak rate for events similar to the September 20, 2022, incident. Consult [EEMUA Publication 191](#), Chapter 6.5.1, for guidance regarding abnormal condition performance levels. Apply the improved performance levels where applicable, but specifically to the Crude 1 control board alarm performance.

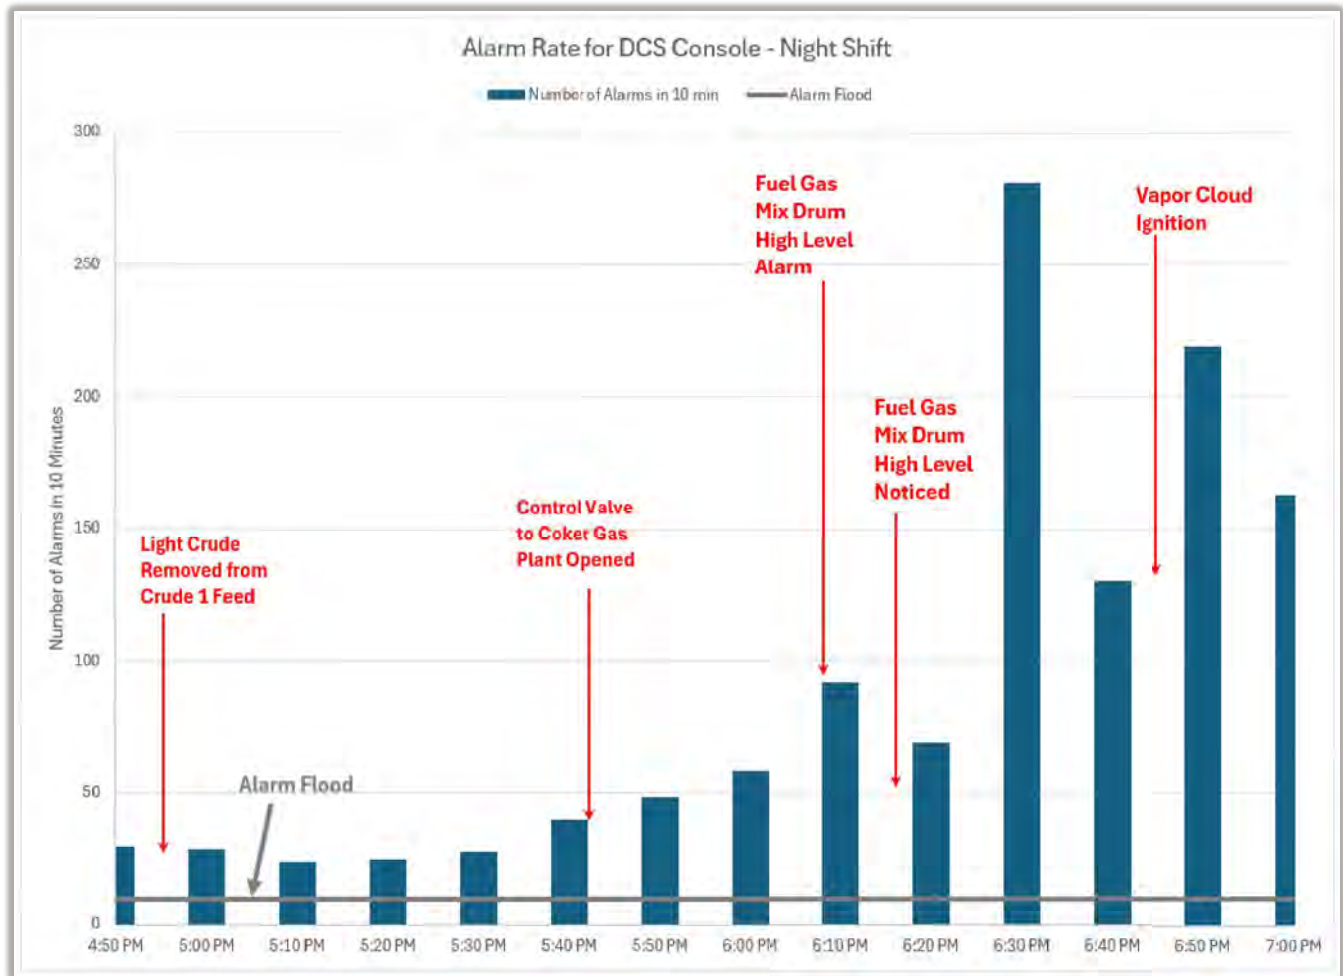
**Figure 37:** DCS console alarm rate on night shift, with some process events (in red). The gray line indicates alarm flood rate. (Credit: CSB)

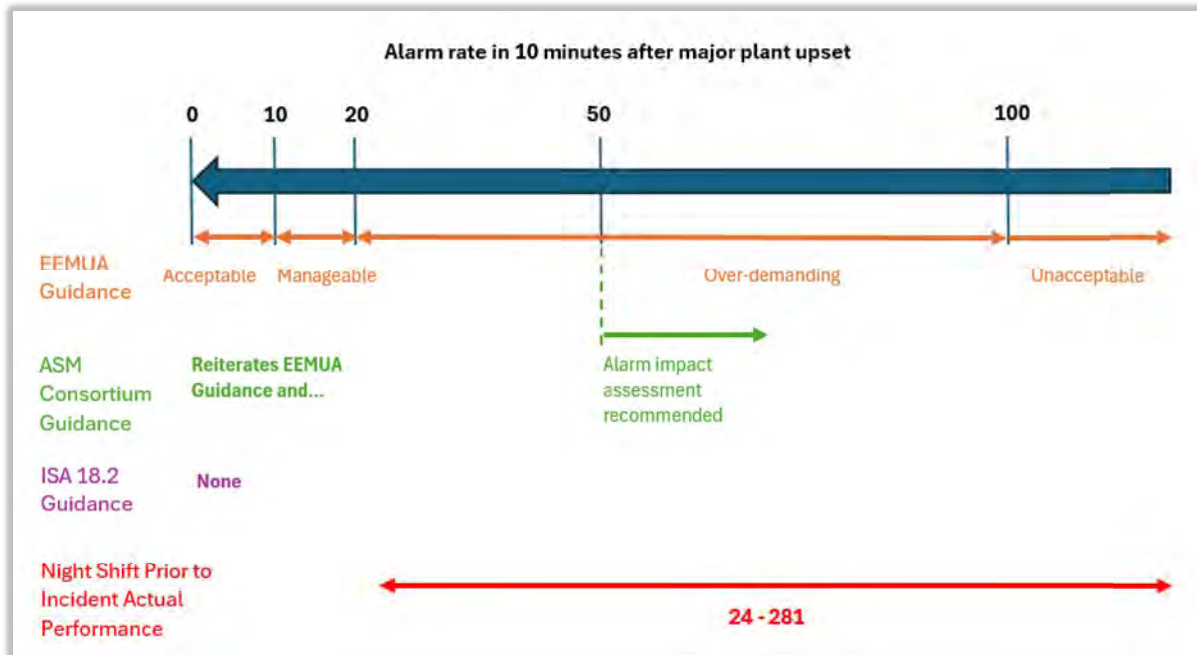
**Figure 40:** Alarm rate guidance and actual performance following a process upset [35, p. 103]. (Credit: CSB)

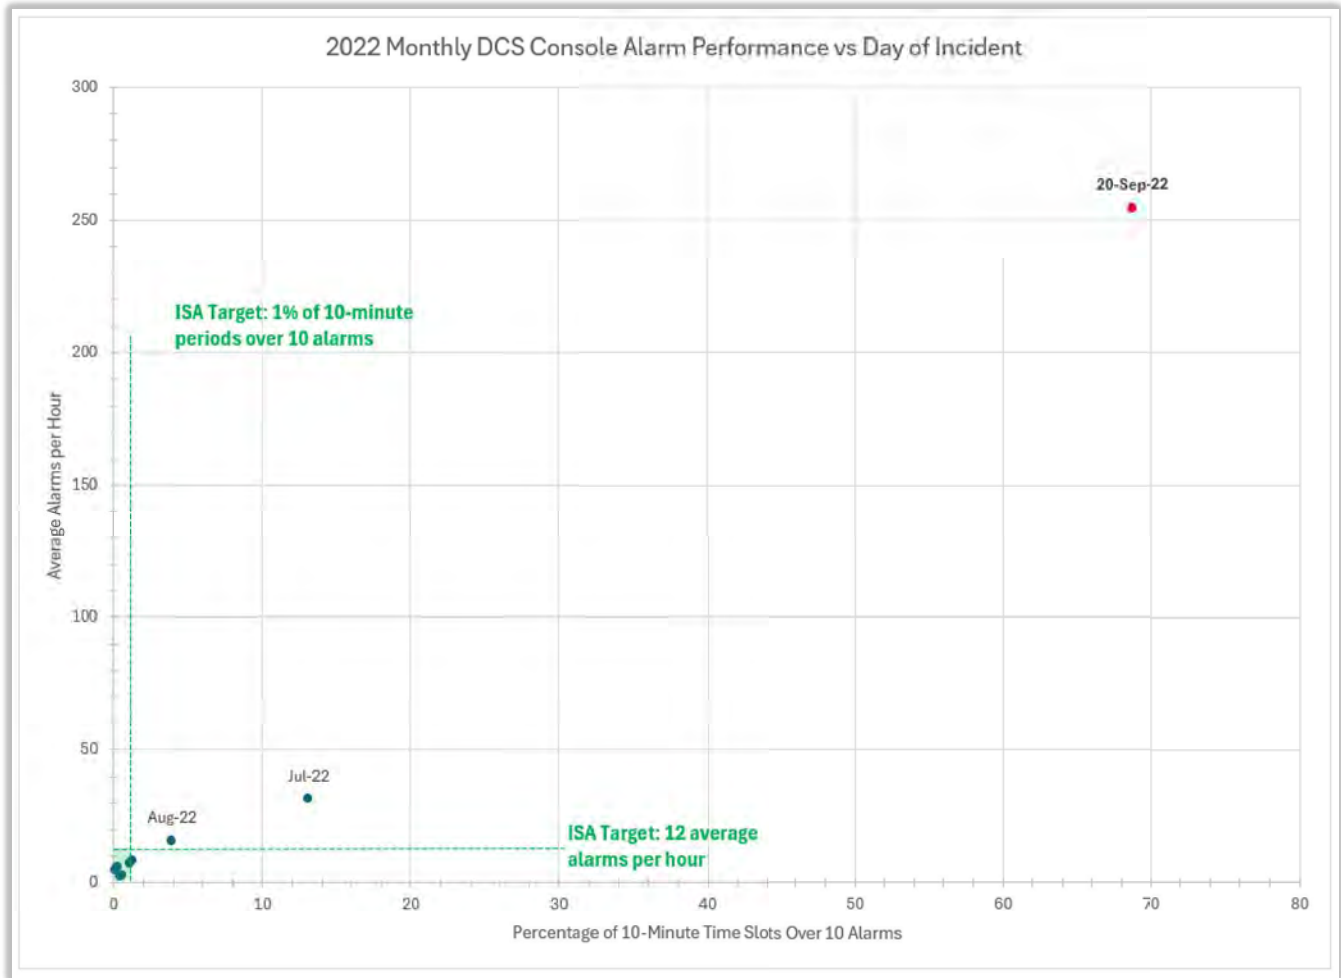
**Figure 41:** BP Toledo Refinery DCS console alarm performance compared with ISA 18.2 targets (green dotted lines), both monthly (blue dots) and for the day of the incident (red dot) [34, p. 78]. The green shaded area in the lower left corner shows ISA 18.2 target performance. (Credit: CSB)

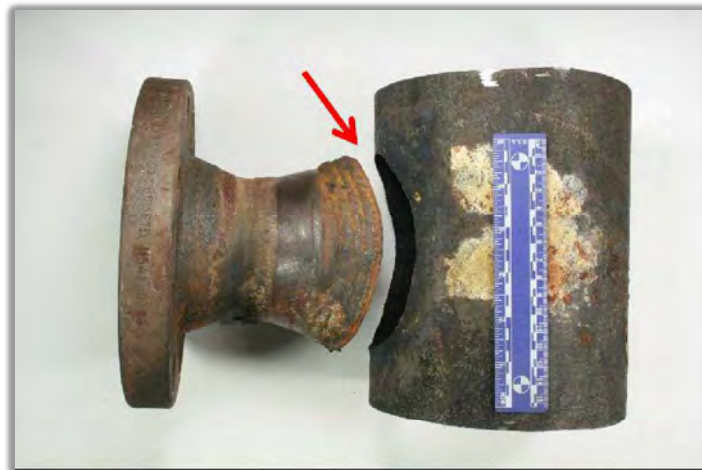
**Figure A1-1.** Failed branch fitting from the BP Whiting Refinery. (Credit: BP)

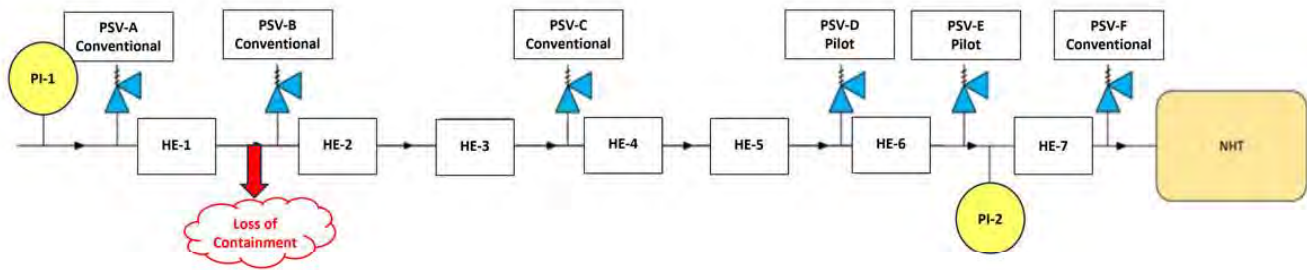
**Figure A1-4.** Location of loss of containment. (Credit: BP with annotations by CSB)

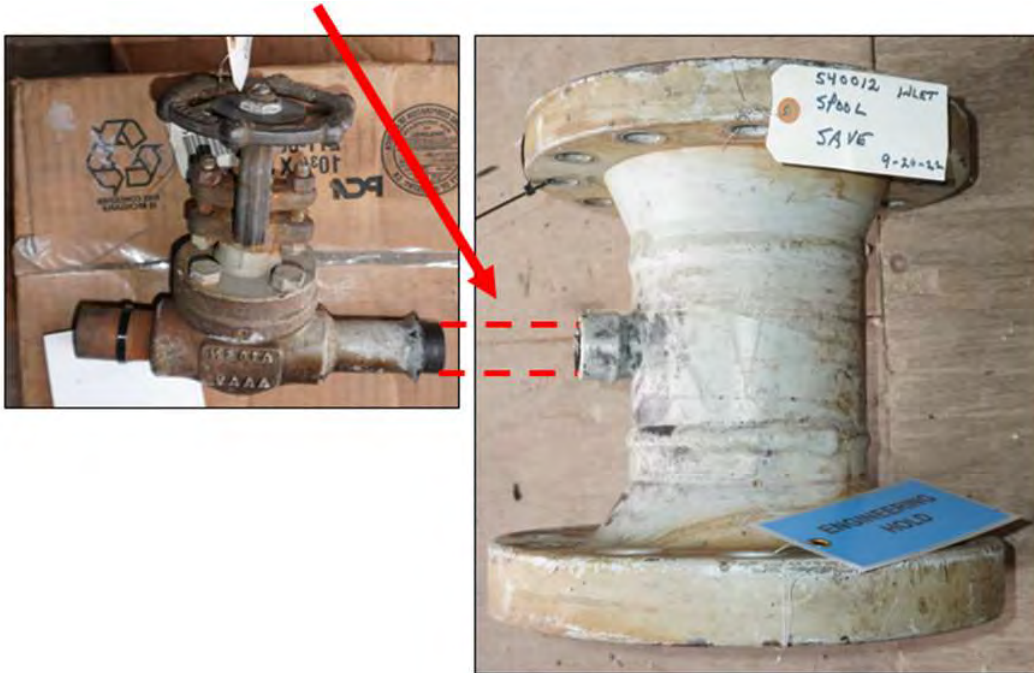
Figure A1-5. Failed ¾-inch branch fitting from the BP Toledo Refinery. (Credit: CSB)
