Jones & Henry Engineers, Ltd. 3103 Executive Parkway, Suite 300, Toledo, OH 43606

Raw Water Main Route

Study Objectives

- Review previous condition assessment reports
- Develop recommendations for repair or replacement of 78-inch raw water main

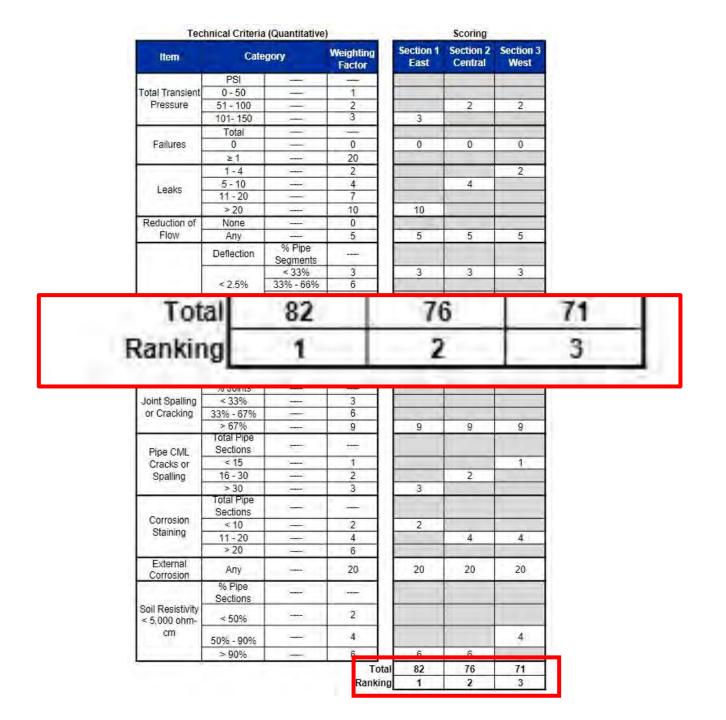
Condition Assessment Technical Criteria

Tec	hnical Criteria	(Quantitative)		Scoring	
Item	Cate	gory	Weighting Factor	Section 1 East	Section 2 Central	Section : West
	PSI	-	-			
Total Transient	0 - 50		1			
Pressure	51 - 100		2		2	2
	101- 150		3	3		
	Total					
Failures	0		0	0	0	0
	≥1		20			
						2
Leaks					4	
Leans	11 - 20	-	7	1		
	> 20		10	10		
Reduction of	None	-	0			
Flow	Any		5	5	5	5
	Deflection					
			3	3	3	3
	< 2.5%	33% - 66%	6	1		
8		> 66%	9	1		
Pipe		< 33%	6			
Deflection	2.5% - 5%	33% - 66%	9		9	9
		> 66%	12	12		
		< 10%	9	9

2.75	10% - 20%	12		12	12
		> 20%	15			
	% Joints					
Joint Spalling	< 33%					
or Cracking			6			
		3000	9	9	9	9
Pipe CML	Total Pipe Sections	i i	De l			
Cracks or	< 15	(1-4-4)	- 1	1		1
Spalling	16 - 30	()	2		2	
	> 30		3	3		
0	Total Pipe Sections		-		2 0 4 5 3 9 12	
Corrosion Staining	< 10		2	2		
Stairing	11 - 20		4		4	4
	> 20	-	6	Section 1 Section Central		
External Corrosion	Any	()	20	20	20	20
	% Pipe Sections	()	(-u-			
Soil Resistivity < 5,000 ohm-	< 50%	-	2			
cm	50% - 90%	-	4			4
	> 90%	-	6			
					76	71
			Dankin	a 1	2	3
