## Investigation Report

Published: June 2024

## U.S. Chemical Safety and Hazard Investigation Board

The September 20, 2022, naphtha release and fire at the BP-Husky Toledo Refinery fatally injured two employees, who were brothers:

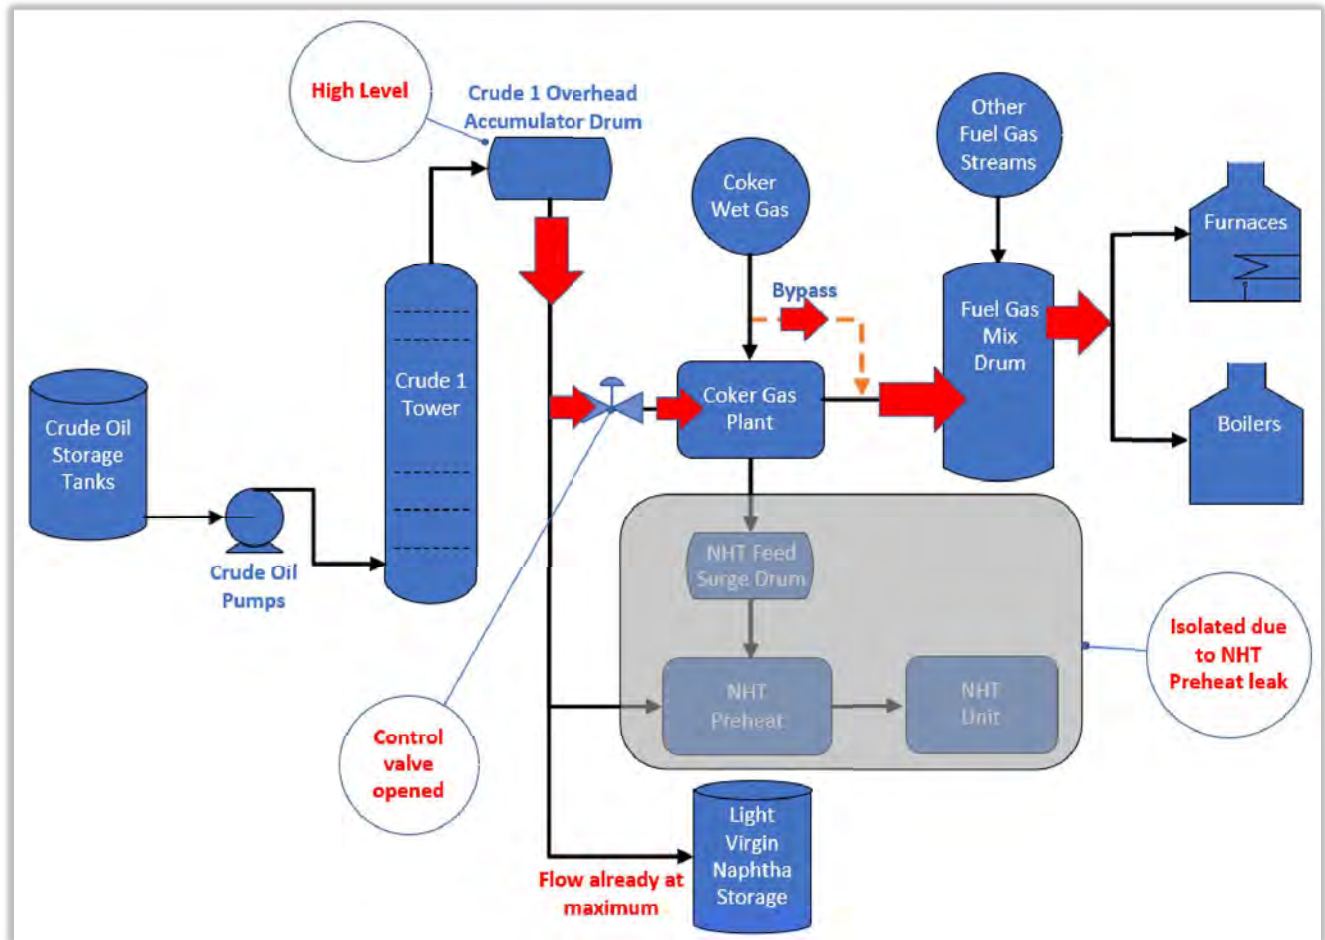
**Figure 9** shows the liquid naphtha overflow from the Crude 1 Overhead Accumulator Drum to the Absorber Stripper Tower, the overflow from the Absorber Stripper Tower to the Fuel Gas Mix Drum, and the overflow to the furnaces and boilers downstream of the Fuel Gas Mix Drum.

**Figure 9:** Summary of overflow from the Crude 1 Overhead Accumulator Drum to the Absorber Stripper Tower in the Coker Gas Plant, and on to the Fuel Gas Mix Drum and downstream furnaces and boilers. (Credit: CSB)

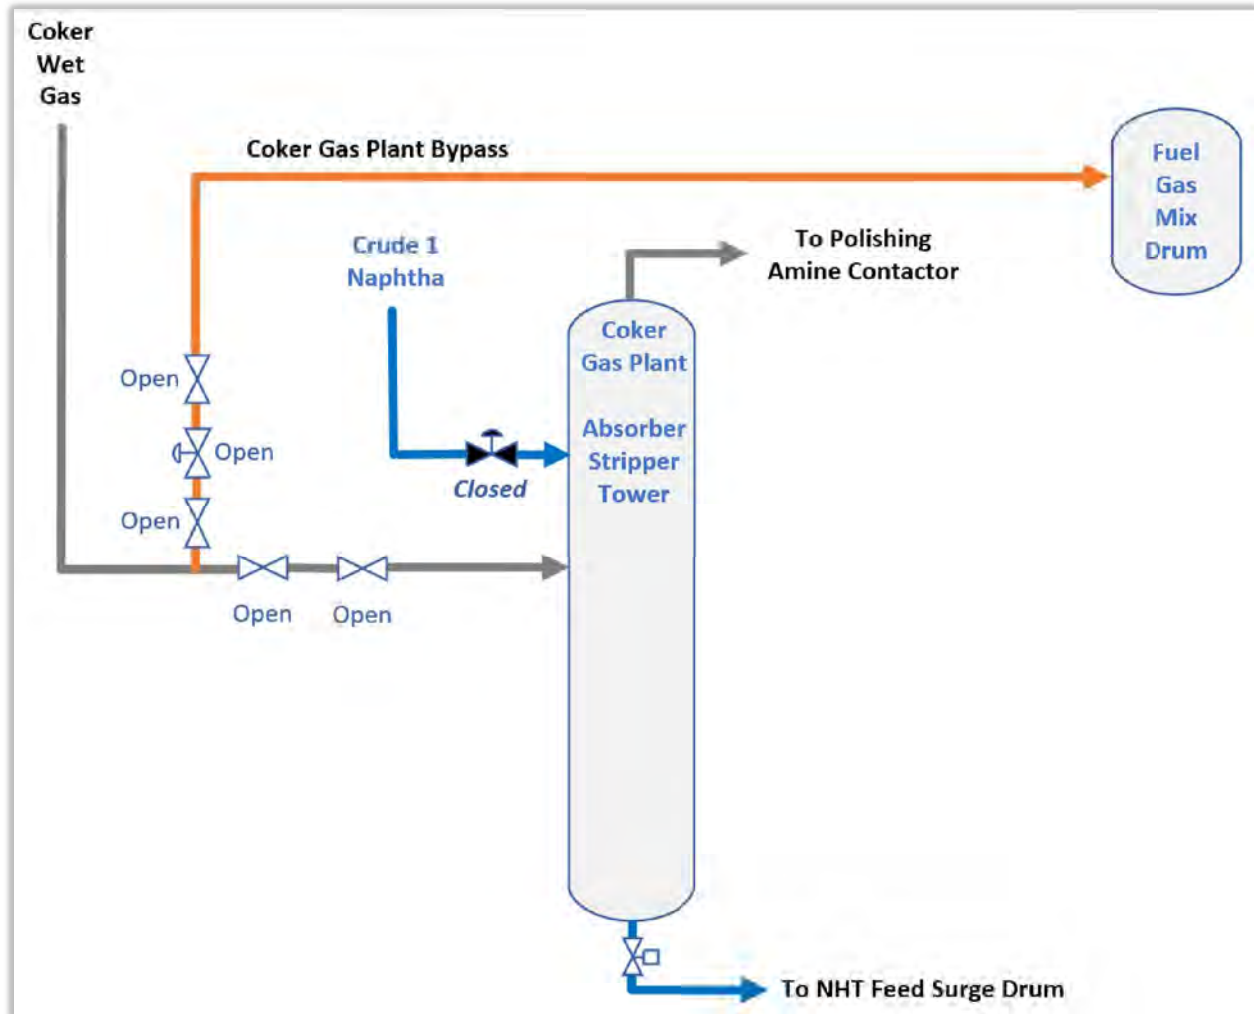
**Figure 18:** Coker Gas Plant bypass configuration on the day of the incident. (Credit: CSB)

The CSB concludes that the NHT unit emergency shutdown necessitated bypassing the Coker Gas Plant, but the Coker Gas Plant was not fully isolated, even though its operational state was considered “in bypass.” Bypassing the Coker Gas Plant left an open flow path from the Absorber Stripper Tower to the Fuel Gas Mix Drum.

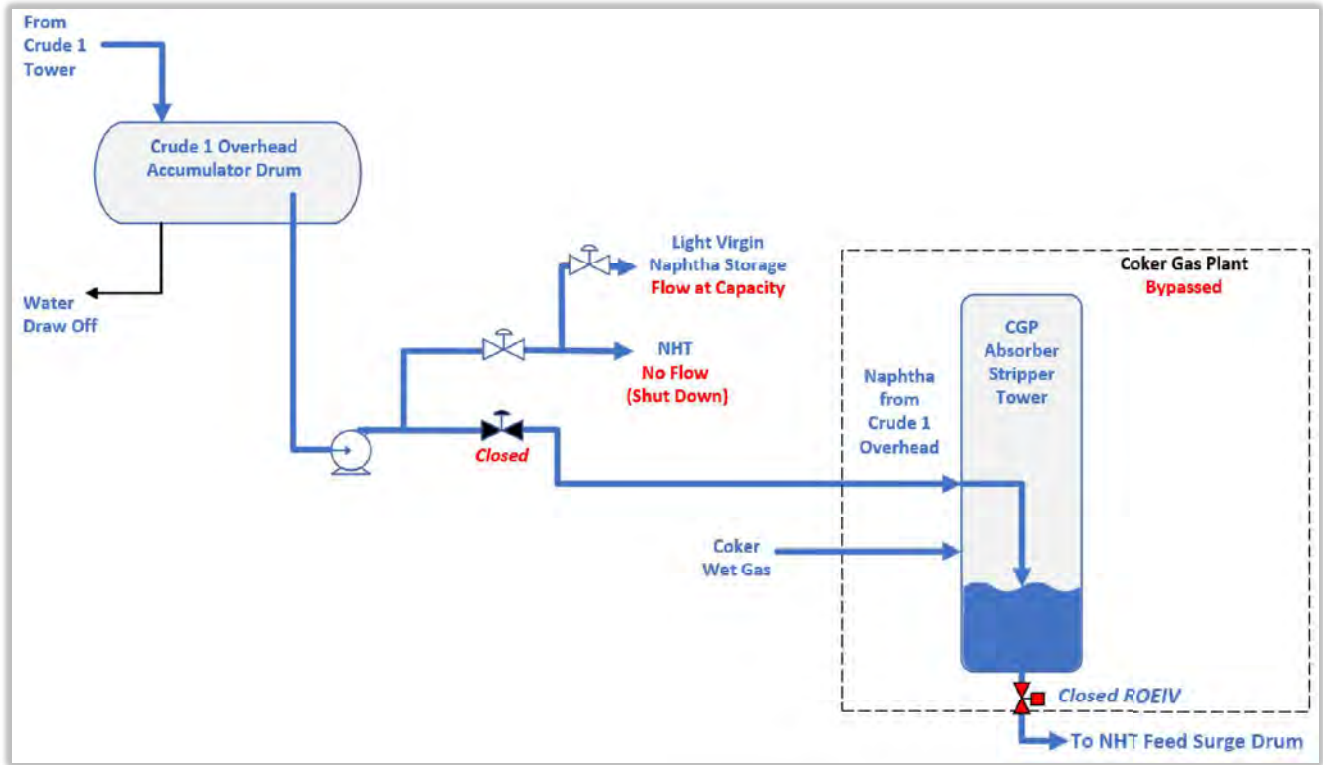
With the NHT unit shut down and the Coker Gas Plant bypassed, naphtha from the Crude 1 Overhead Accumulator Drum could be sent only to Light Virgin Naphtha Storage, as shown below in **Figure 19**. However, the liquid level in the Accumulator Drum could not be maintained with the Light Virgin Naphtha flow control valve solely. For the majority of time between 1:30 p.m. and 3:30 p.m., while the flow control valve was near or at its fully open position, the accumulator drum level exceeded its high-high alarm setpoint, and the flow reading to the Light Virgin Naphtha Storage was above the meter’s range, as shown below in **Figure 20**.

Figure 19: Liquid naphtha flow paths out of the Crude 1 Overhead Accumulator Drum. (Credit: CSB)

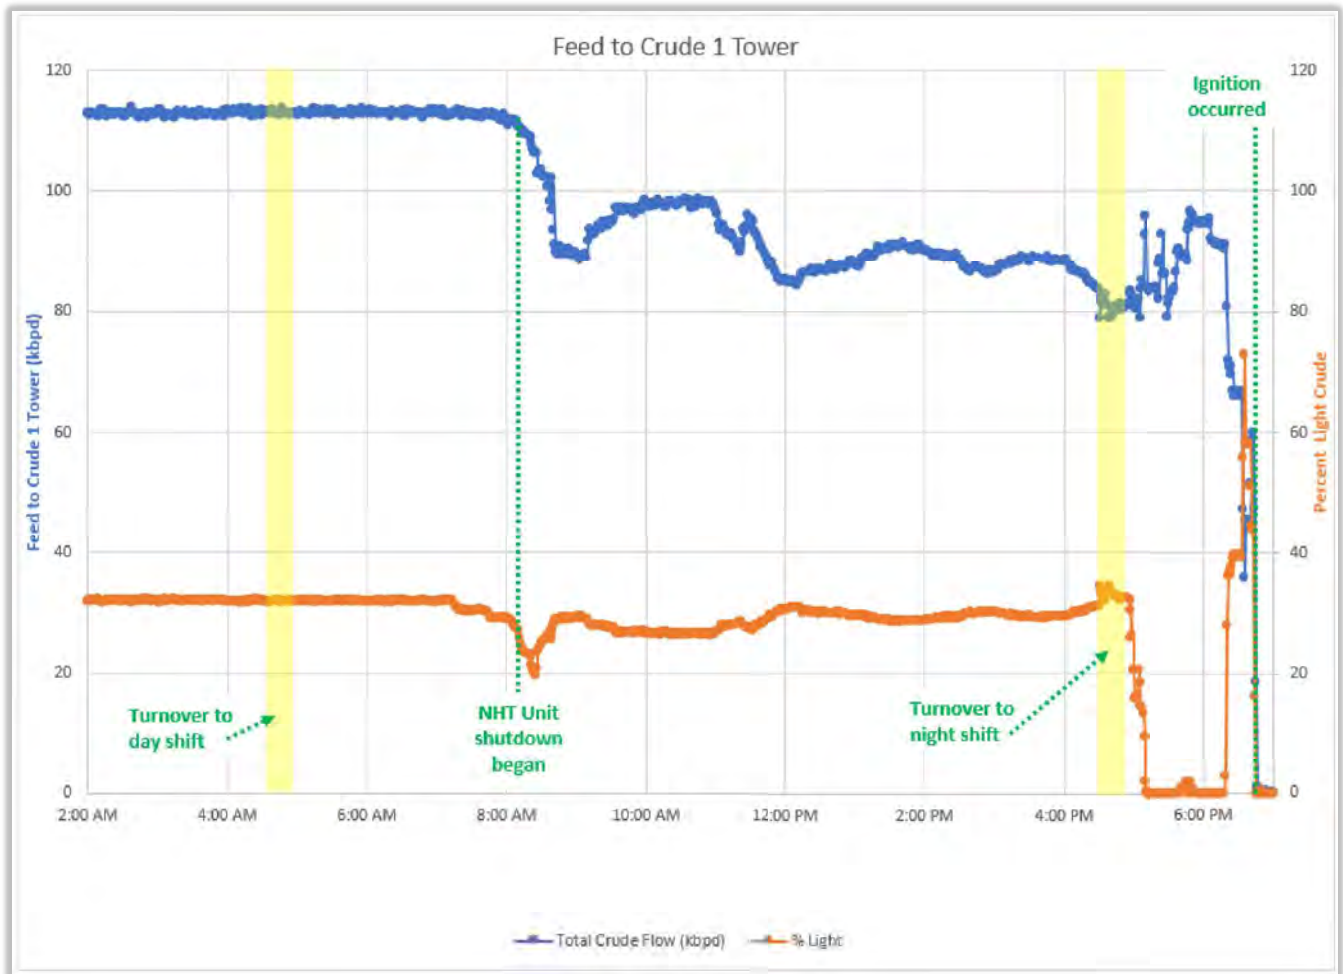
In response to the NHT unit shutdown and Coker Gas Plant bypass earlier that day, the crude slate to the Crude 1 Tower had been adjusted several times throughout the day as operations personnel worked to stabilize the tower. Night shift personnel arrived at approximately 4:30 p.m. on September 20, 2022, and shortly afterward, a significant crude slate change to the Crude 1 Tower occurred. Light crude oil flow was 26,000 barrels per day, or approximately 32 volume percent of the total feed, at 4:56 p.m., but it was eliminated entirely by 5:10 p.m. A board operator cut the light crude feed because he thought the light crude oil flow was too high given that the NHT unit was down. Another online crude oil pump, connected to heavy crude oil storage, automatically increased speed to maintain the total feed flow rate to the Crude 1 Tower. Abruptly replacing light crude oil feed with heavy crude oil created a large and rapid change in the crude oil composition, which reached the Crude 1 Tower approximately 40 minutes later. **Figure 22** shows the crude oil compositions and flow rates feeding the Crude 1 Tower before and after the light crude oil flow stopped.

**Figure 22:** Crude 1 Tower Feed rate (blue) and percent light feed composition (orange) day of incident. The yellow bars indicate shift change turnover. (Credit: CSB)

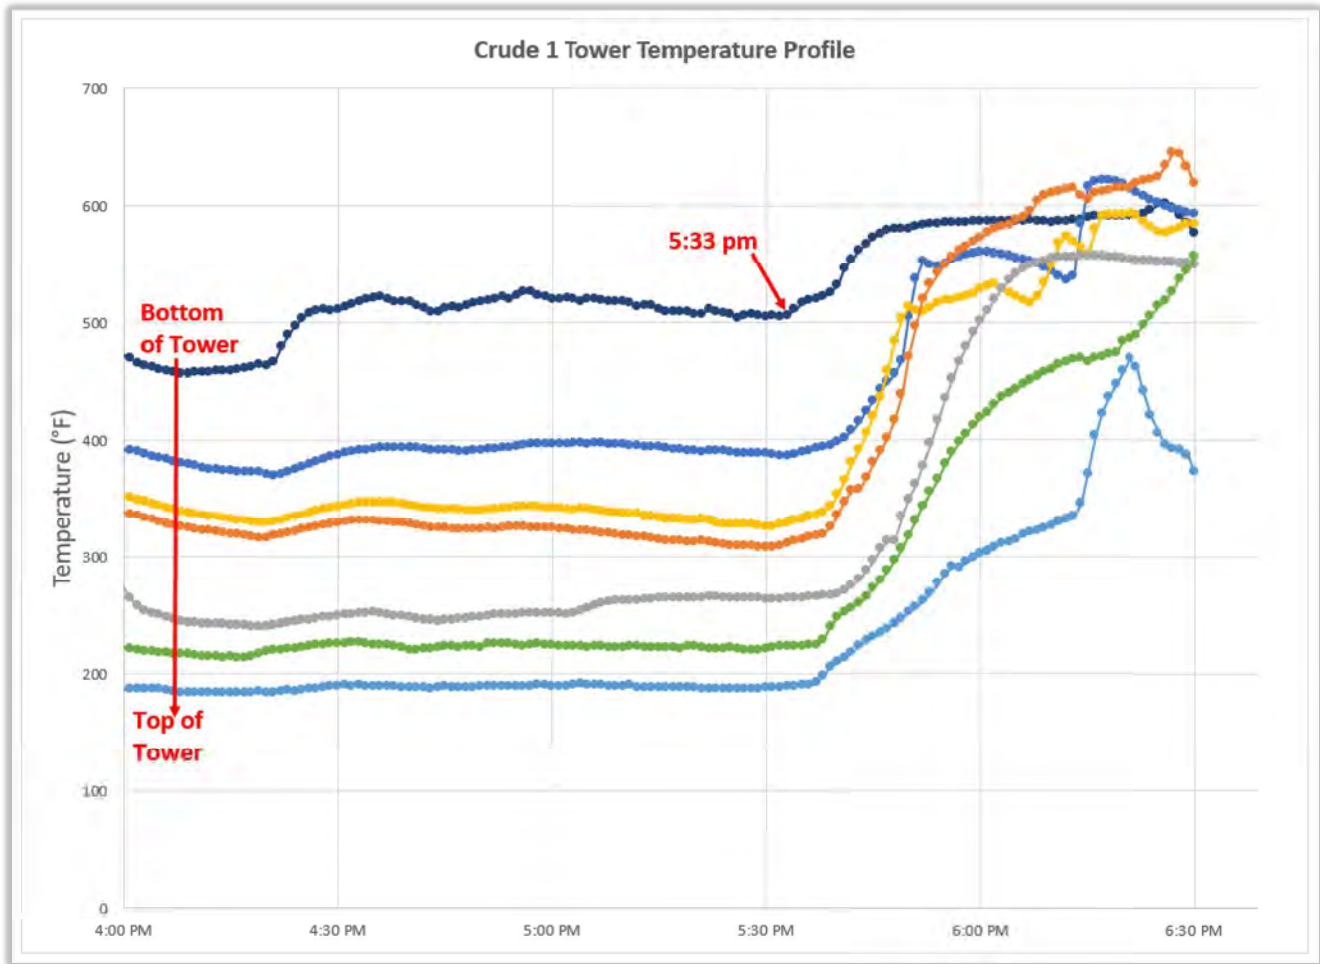
At approximately 5:30 p.m., Crude 1 Tower temperatures began to increase rapidly, initiating the Crude 1 Tower upset, as shown in **Figure 23** below.

**Figure 23:** Crude 1 Tower temperature profile. Before the upset, temperatures are hottest at the bottom of the tower and decrease going up the tower, normal for any distillation tower. (Credit: CSB)

As tower temperatures increased, there was not enough liquid volume in the Crude 1 Tower pumparound circuits to maintain the vapor-liquid interface in each section of the Tower and to ensure sufficient cooling. As the pumparound flows successively dropped to zero (bottom at 5:41 p.m., middle at 5:47 p.m., and top at 6:13 p.m.), the Crude 1 Tower temperature profile further increased. Volatile materials in the tower flashed due to the increased temperatures, which led to high level in the Crude 1 Overhead Accumulator Drum as the increased vapor flow condensed in the overhead coolers.

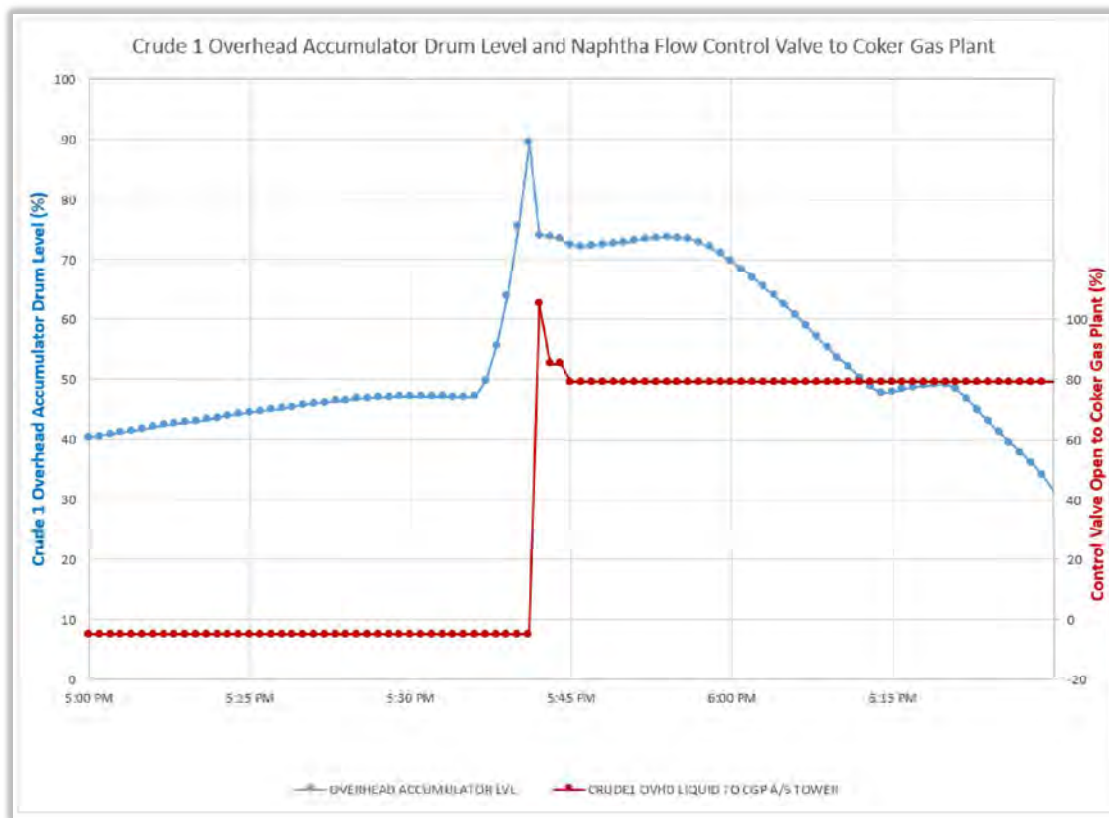
The Crude 1 Tower upset created a tower overhead flow surge a few minutes later, which in turn filled the Crude 1 Overhead Accumulator Drum. Within a five-minute period, the Crude 1 Overhead Accumulator Drum level rose from a steady state of 47 percent to 68 percent (the high level alarm), to 70 percent (the high-high level alarm), and finally to 89 percent level at 5:40 p.m. The Crude 1 Overhead Accumulator Drum level increased so rapidly that the level indication went from 65 percent to 89 percent in less than two minutes. In response to this rapid level increase, the board operators searched for ways to reduce level in the drum quickly. With other liquid naphtha flow paths out of the Crude 1 Overhead Accumulator Drum already either at full capacity or shut down,<sup>a</sup> a board operator opened the naphtha flow control valve to the Coker Gas Plant in an effort to reduce the Crude 1 Overhead Accumulator Drum level even though the Coker Gas Plant was intended to be bypassed at the time. **Figure 24** below shows this valve opening (in red) and the Crude 1 Overhead Accumulator Drum's rapid level increase and resulting decrease (in blue) after the naphtha flow control valve to the Coker Gas Plant was opened.

**Figure 24:** Crude 1 Overhead Accumulator Drum level (blue) and naphtha flow control valve to the Coker Gas Plant opening (red) in response to the high level. (Credit: CSB)

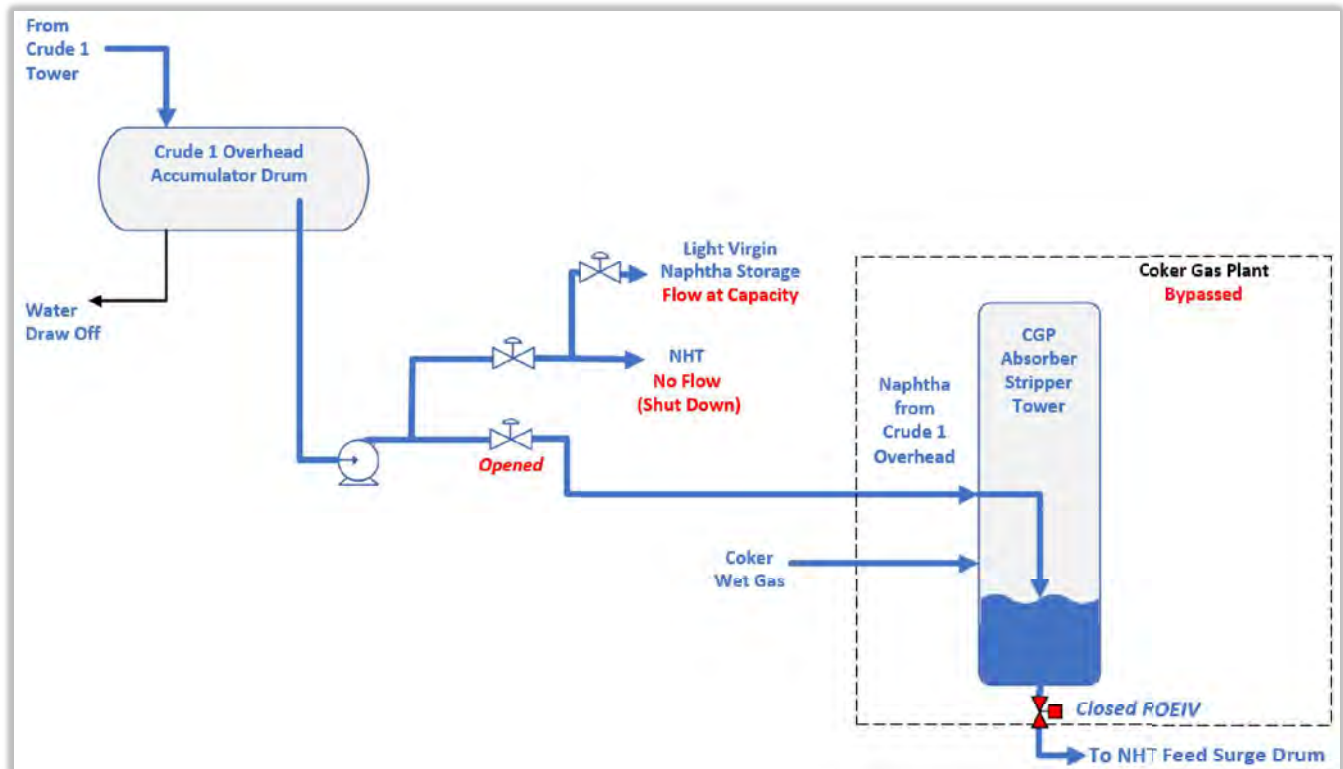
The night shift board operators were unaware that earlier that day, the day shift had closed a valve on the Coker Gas Plant Absorber Stripper Tower bottoms piping, known as a Remotely Operated Emergency Isolation Valve (ROEIV). This closed valve prevented flow through the Absorber Stripper Tower bottoms into the NHT Feed Surge Drum, so the liquid naphtha began to fill the Coker Gas Plant Absorber Stripper Tower more quickly than if the ROEIV had remained open. **Figure 25** illustrates the flow path from the Crude 1 Overhead Accumulator Drum to the Coker Gas Plant Absorber Stripper Tower.

**Figure 25:** Flow path from Crude 1 Overhead Accumulator Drum to Coker Gas Plant. (Credit: CSB)

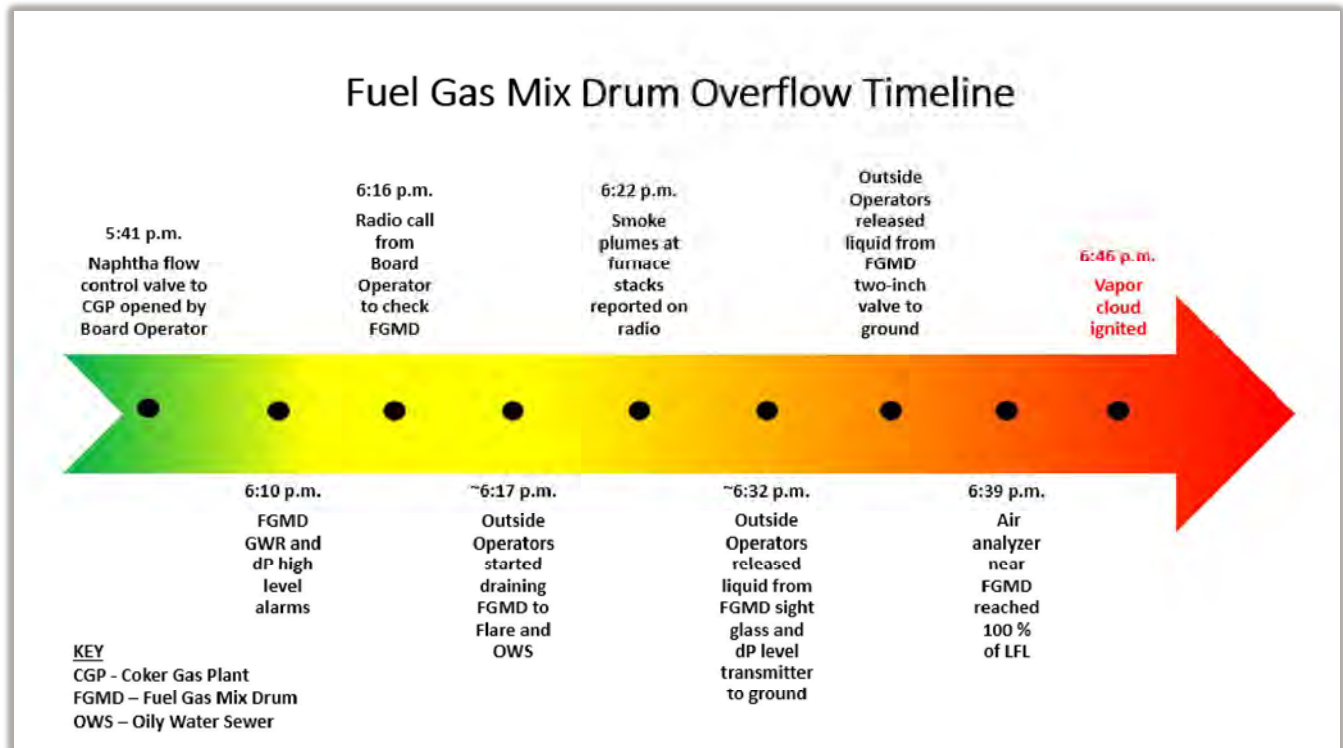
**Figure 27** shows a summary timeline of some of the key events in the hour preceding the incident, showing limited time available to refinery personnel for decision-making. **Appendix A.2.9.4** contains a detailed timeline of the event.

**Figure 27:** Summary timeline of some key events for the hour preceding the incident. (Credit: CSB)

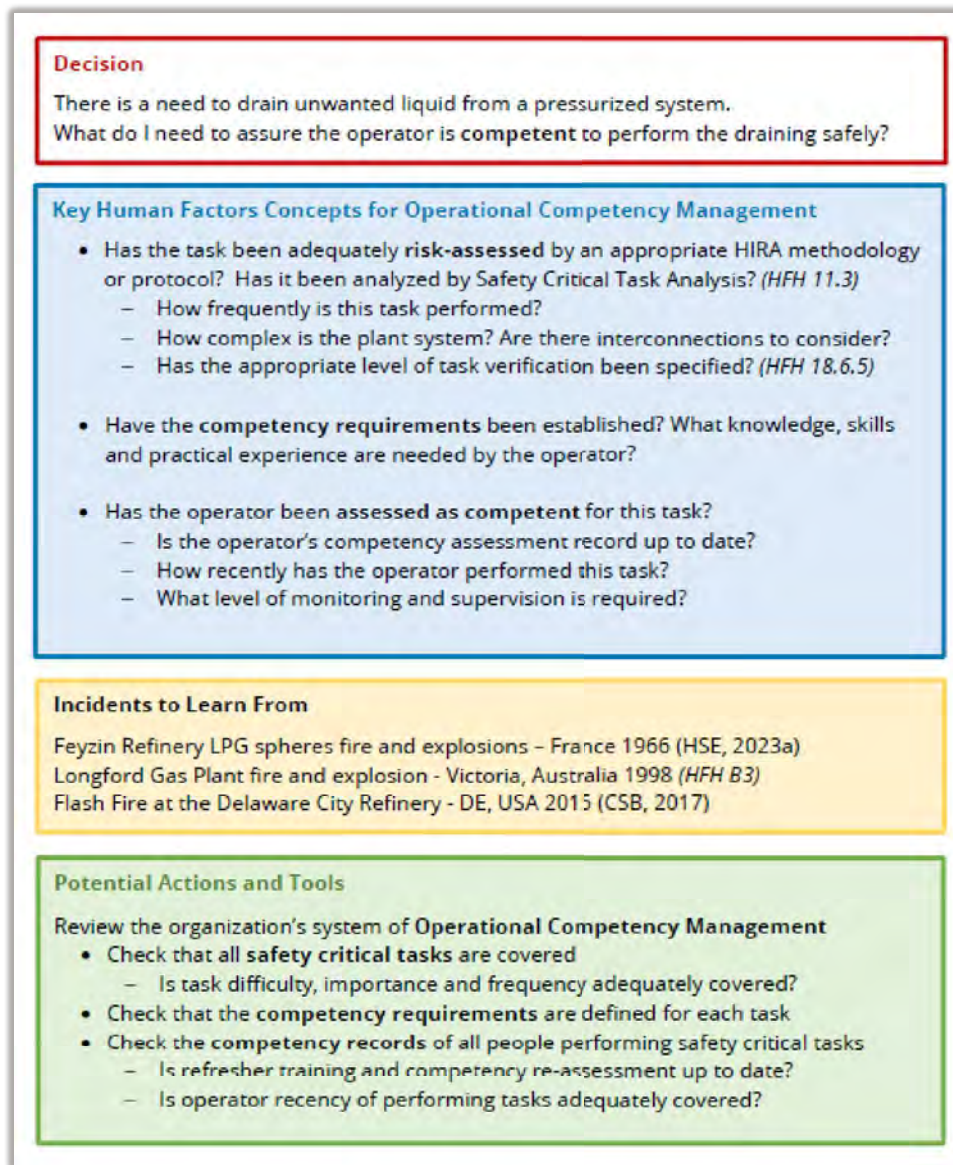
**Figure 31:** Draining unwanted liquid from a pressurized system. (Credit: CCPS)

In **Figure 31** above, the CCPS states that the task of draining a pressurized vessel should be adequately risk-assessed by considering the frequency of the task, the complexity of the system including interconnections, and the levels of required task verification. Had the BP Toledo Refinery conducted a similar assessment of the task of manually draining the Fuel Gas Mix Drum, it may have identified the potential for naphtha filling the drum

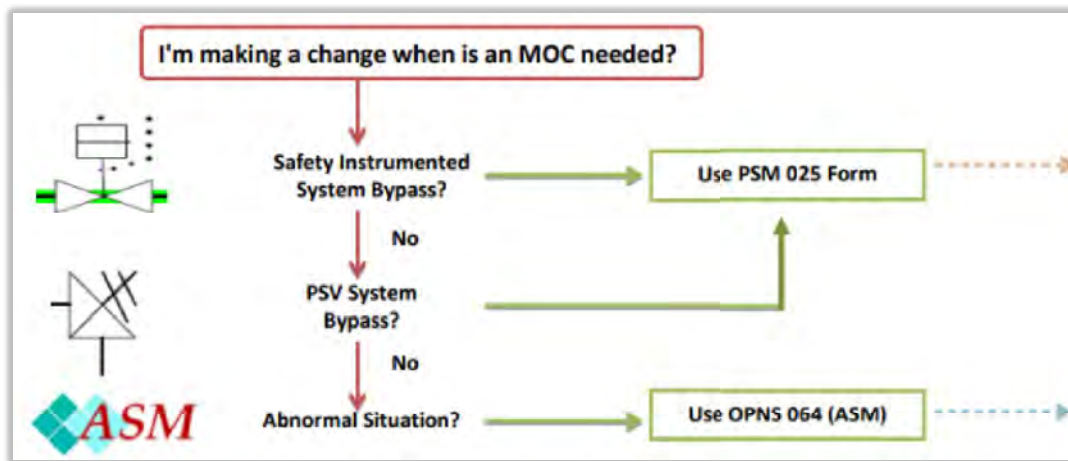
In effect, the BP Toledo Refinery’s ASM policy was more of an emergency MOC procedure than instructions for truly handling abnormal situations as the ASM<sup>®</sup> Consortium defines them.<sup>b</sup> This is shown in the BP Toledo Refinery ASM policy itself, in **Figure 33** below, where it is indicated as a type of MOC.

**Figure 33:** Excerpt of the BP Toledo Refinery ASM procedure, indicating its relation to MOC. (Credit: BP)

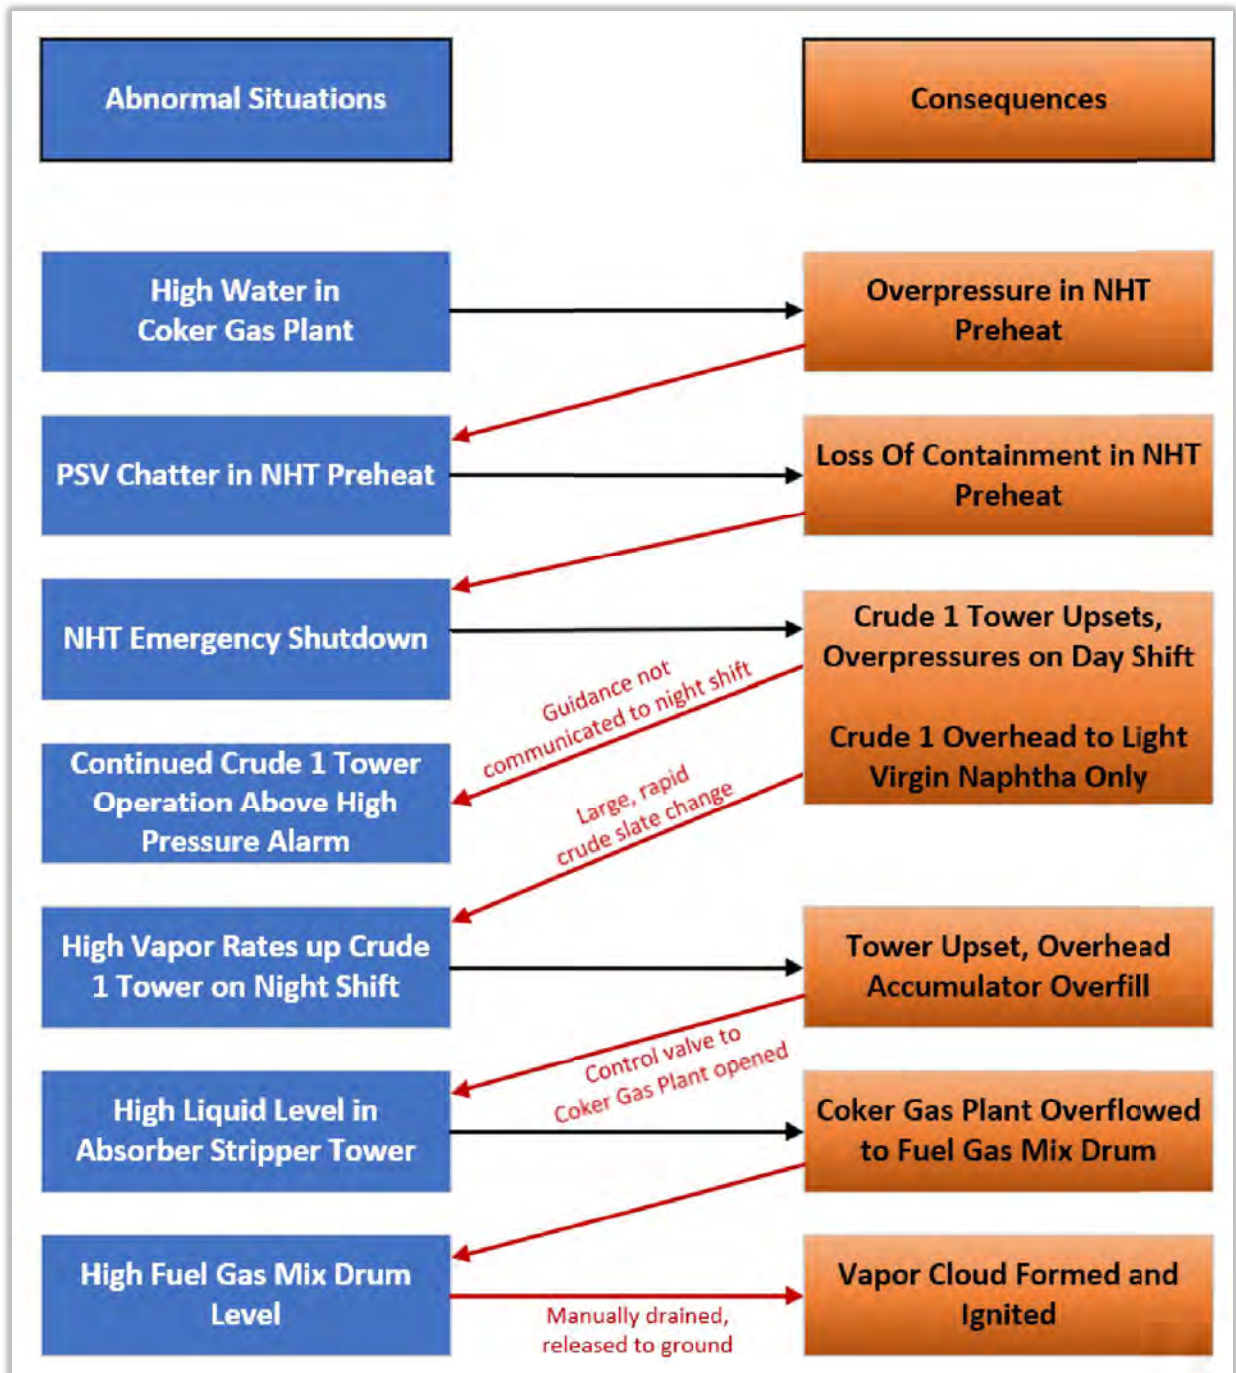
As an illustration of how some abnormal situations can cascade to escalating consequences, **Figure 35** shows several abnormal situations that occurred on the day of the incident, their consequences, and how those consequences and other decisions led to the next abnormal situation, escalating throughout the day.

Throughout the day, abnormal situations continued to escalate, culminating in the release of naphtha from the Fuel Gas Mix Drum to the ground, resulting in a fatal fire. None of the decisions made that day were made in a vacuum; instead, they were frequently made in response to other previous abnormal situations and their consequences (shown in red in **Figure 35** below). These are examples of situations that can affect the performance of board operators, outside operators, or refinery management performance [1, pp. 87-88].

**Figure 35:** Examples of abnormal situations the day of the incident (in blue), and the consequences of them (in orange). Note that in some cases, consequences and decisions contributed to the next abnormal situation (in red). (Credit: CSB)

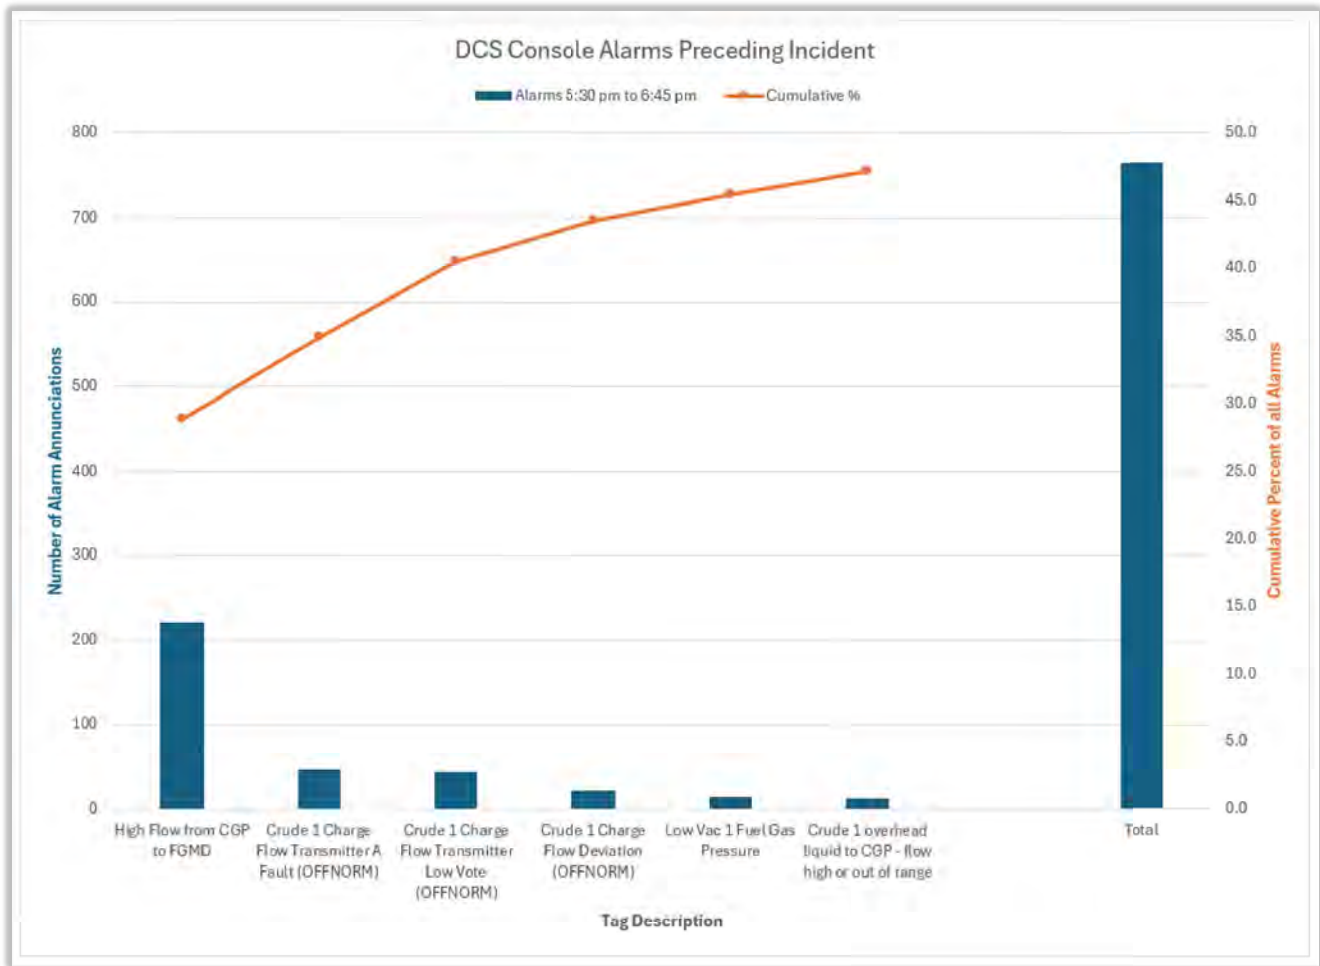
However, despite using some tools, alarm flood occurred during the September 20, 2022, process upsets as shown in **Figure 37** above. For example, from 5:30 p.m. to 6:45 p.m. (approximately from the time the Crude 1 Tower upset began to the time that the fatal incident occurred), the DCS console received 765 annunciated alarms. Out of the 203 different tags that created alarms during this time, the six most frequent alarms accounted for nearly half of the alarm annunciations (47.2 percent). The most frequent alarm went off 22 times in one minute at 6:30 p.m., or on average once every 2.7 seconds, when board operators were already overwhelmed with alarms. **Figure 42** below shows the top six most annunciated alarms during this time.

**Figure 42:** Most frequent alarms annunciated at DCS console between 5:30 p.m. and 6:45 p.m., the hour and 15 minutes preceding the incident. The blue bars show the number of annunciations for each tag, and the orange line shows the cumulative percentage of alarms in that time. (Credit: CSB).

The most frequent alarm, “High Flow from Coker Gas Plant to Fuel Gas Mix Drum,” might have afforded board operators a clue as to the source of liquid entering the Fuel Gas Mix Drum. This flow measurement was normally in gas flow only, not liquid flow, as was occurring before the incident. Significantly, however, the CSB found no evidence that anyone in the control room acted on this alarm. Board operators may have been too overwhelmed with alarm flood to understand why the alarm was annunciating so frequently. In any case, board operators did not take corrective action until after the fatal incident occurred, as the naphtha flow control valve to the Coker Gas Plant remained open until 7:04 p.m., nearly 20 minutes after the incident.

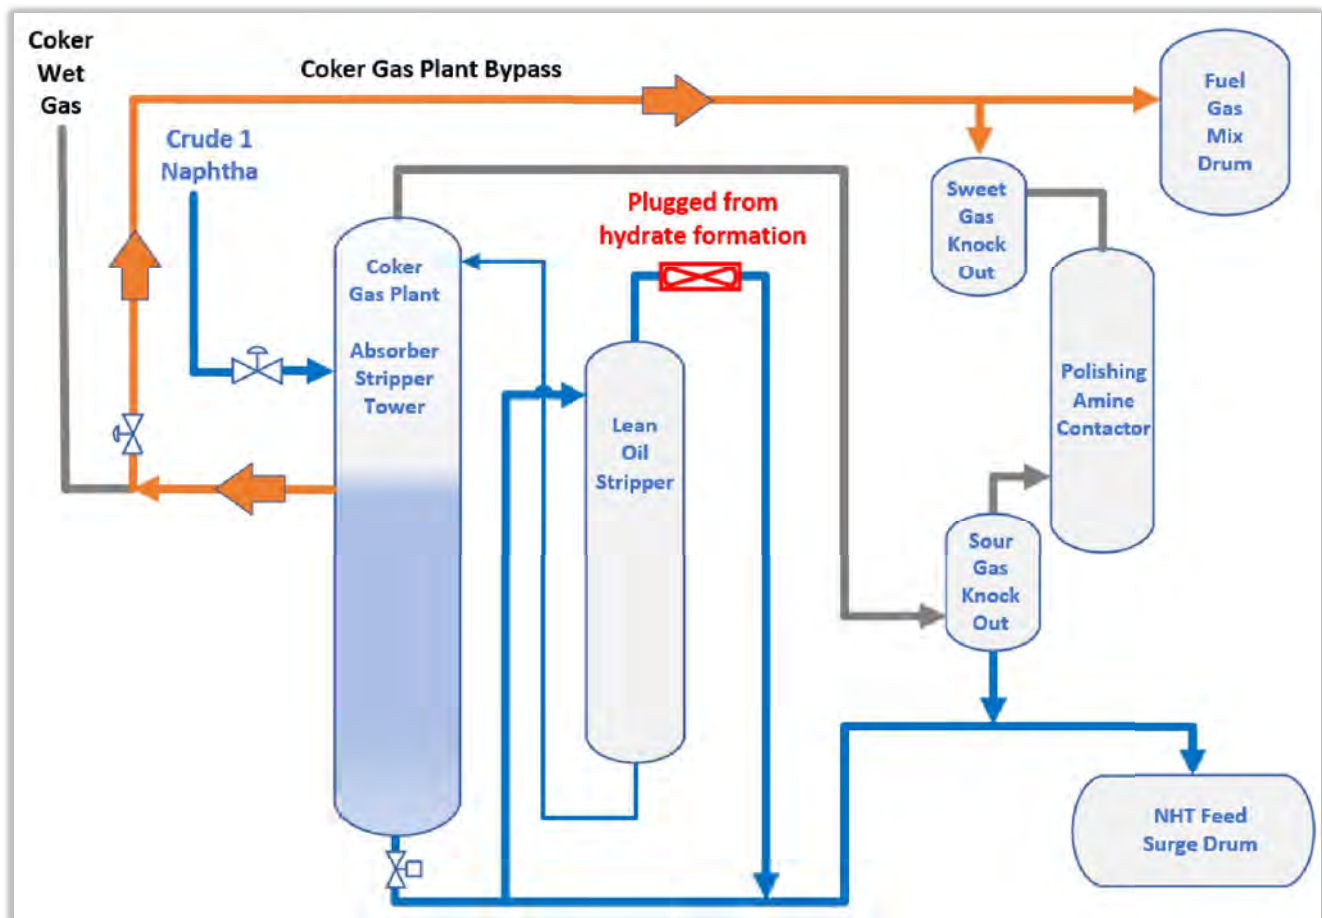
As in the September 20, 2022, incident, during the 2019 incident, naphtha began to fill the Coker Gas Plant Absorber Stripper Tower and, according to the 2019 incident investigation, the naphtha backed up through the Coker Gas Plant bypass due to high pressure that had developed in the Lean Oil Stripper from the hydrate formation. As shown in orange in **Figure 44**, naphtha flowed from the Absorber Stripper Tower through the Coker Gas Plant bypass line. A high liquid level developed in the Fuel Gas Mix Drum and the Polishing Amine Contactor Sweet Gas Knockout Drum. In the 2019 incident, the high liquid level in the Fuel Gas Mix Drum was drained to the Flare Knockout Drum and the Oily Water Sewer. Operations changed the crude slate being fed to the Crude 1 unit to reduce naphtha production and reduced the opening of the naphtha flow control valve to the

**Figure 44.** Coker Gas Plant. Configuration of the Coker Gas Plant during a 2019 refinery upset. (Credit: CSB)

The CSB concludes that the facts, conditions, and circumstances of the 2019 incident show that while operating the Coker Gas Plant with the bypass open, the BP Toledo Refinery did not have adequate safeguards to prevent overflow of naphtha from the Coker Gas Plant to the Fuel Gas Mix Drum.

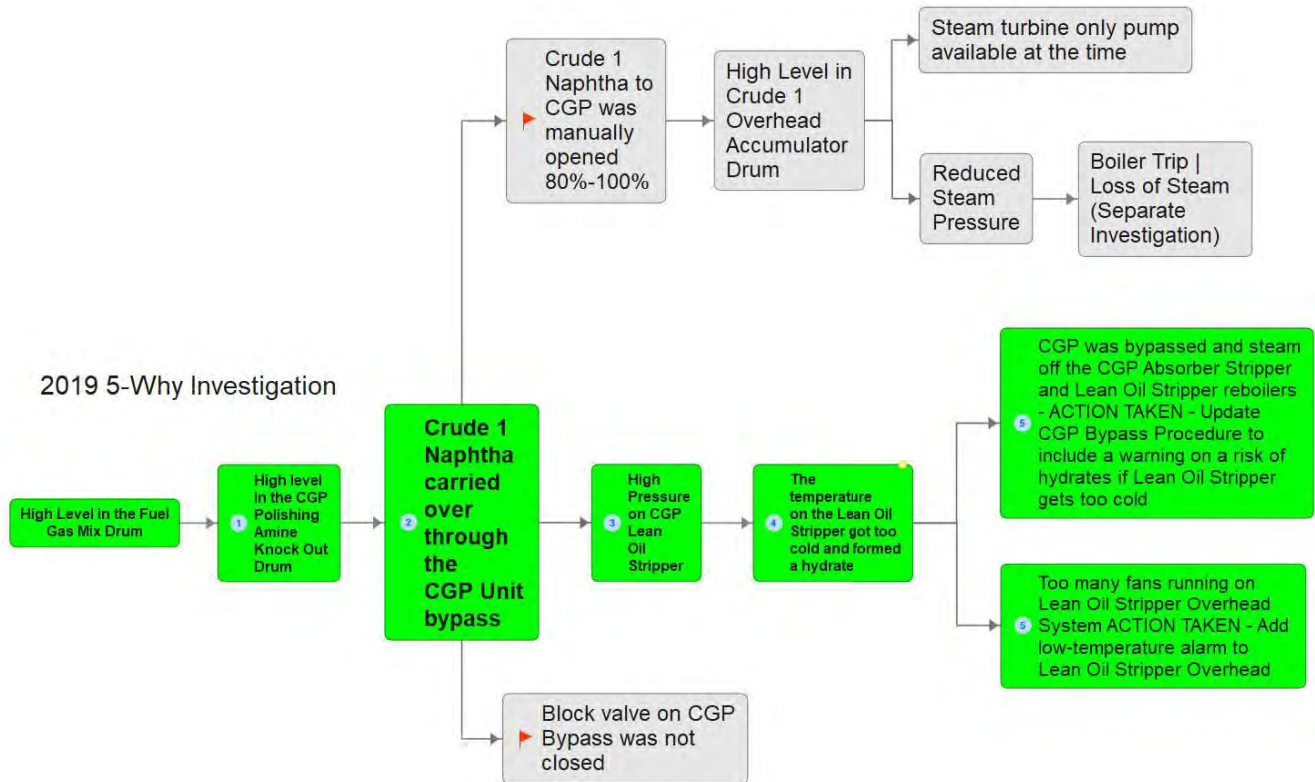
**Figure 46** is a graphical representation of the 2019 Five Whys Investigation shown in **Figure 45**. The red flags indicate causes of high level in the Fuel Gas Mix Drum such as high level in Crude 1 Overhead Accumulator Drum and the open Coker Gas Plant bypass that could have prevented the September 20, 2022, incident, but were not addressed with long term actions to prevent future reoccurrence.

**Figure 46.** Graphical representation of the Five Whys investigation of high level in the Fuel Gas Mix Drum. (Credit: CSB)

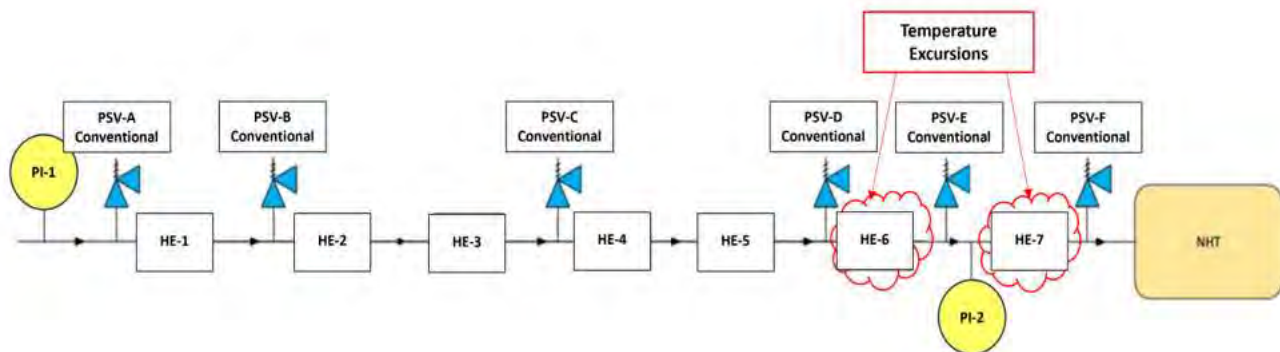
A reduction in the feed rate to the NHT unit at the BP Toledo Refinery resulted in a temperature rise exceeding the maximum allowable working temperature (MAWT) of two heat exchangers, HE-6 and HE-7,<sup>a</sup> in NHT Preheat<sup>b</sup> (See **Figure A1-2**). The temperature excursions lasted approximately four hours.

Over the previous four years, the exchanger HE-7 had multiple temperature excursions above the MAWT.<sup>c</sup>

**Figure A1-2.** Heat exchangers that experienced temperature excursions. (Credit: BP with annotations by CSB)<sup>d</sup>

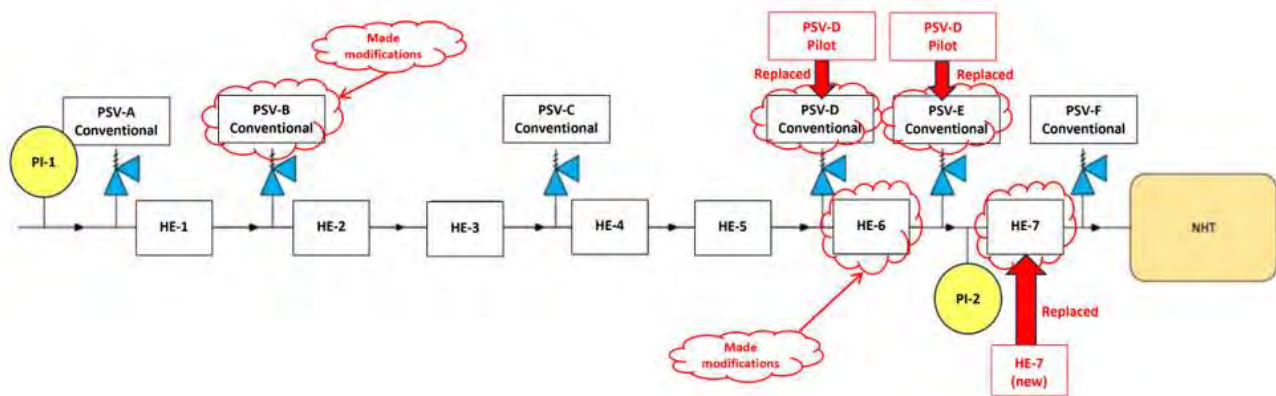
**Figure A1-3.** NHT Preheat changes made during 2022 TAR. (Credit: BP with annotations by CSB)

**Figure A1-3** shows the 2022 TAR work to NHT Preheat which made modifications to heat exchanger HE-6, replaced heat exchanger HE-7, replaced emergency pressure-relief valves PSV-D and PSV-E, and modified PSV-B.

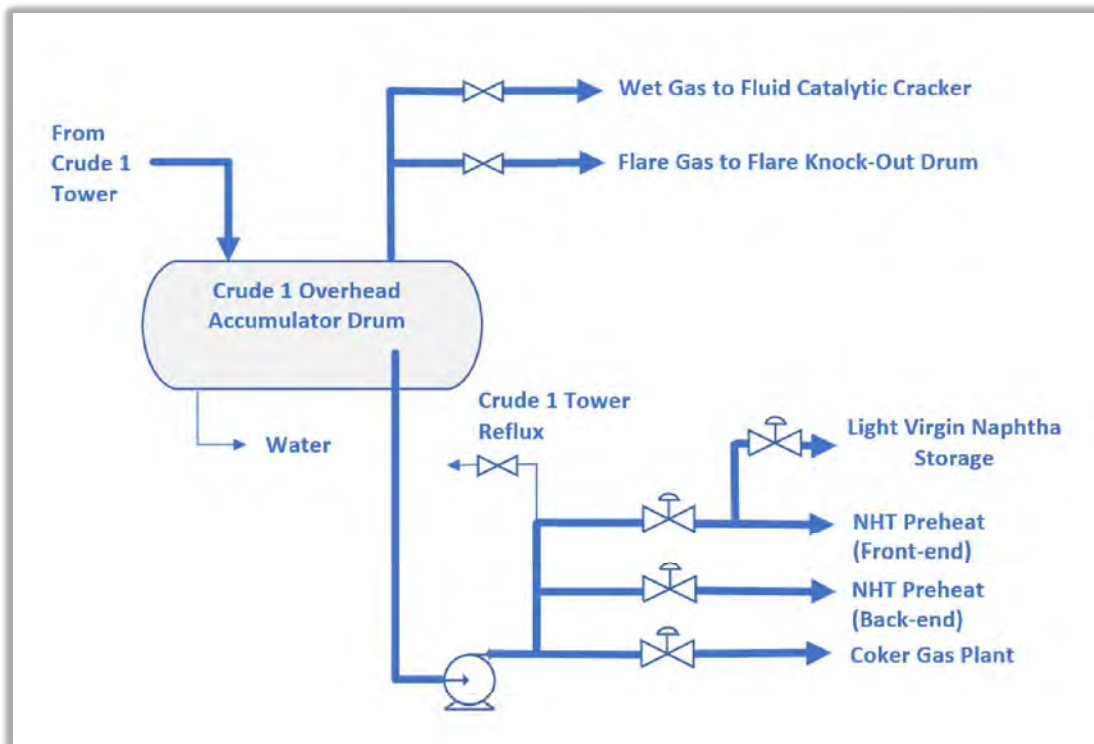
**Figure A2-1** shows how high liquid level in the Crude 1 Overhead Accumulator Drum from process upsets is routed to the Flare Knockout Drum after the Fluid Catalytic Cracker (FCC) unit wet gas compressor is isolated from the Crude 1 Overhead Accumulator Drum overhead flow.

**Figure A2-1.** Crude 1 Overhead Accumulator Drum prior to the installation of the Coker Gas Plant. This simplified schematic shows how high level of liquid in the Crude 1 Overhead Accumulator Drum liquid can overflow to the Flare Knockout Drum. (Credit: CSB)
