## Investigation Report

Published: June 2024

## U.S. Chemical Safety and Hazard Investigation Board

The September 20, 2022, naphtha release and fire at the BP-Husky Toledo Refinery fatally injured two employees, who were brothers:

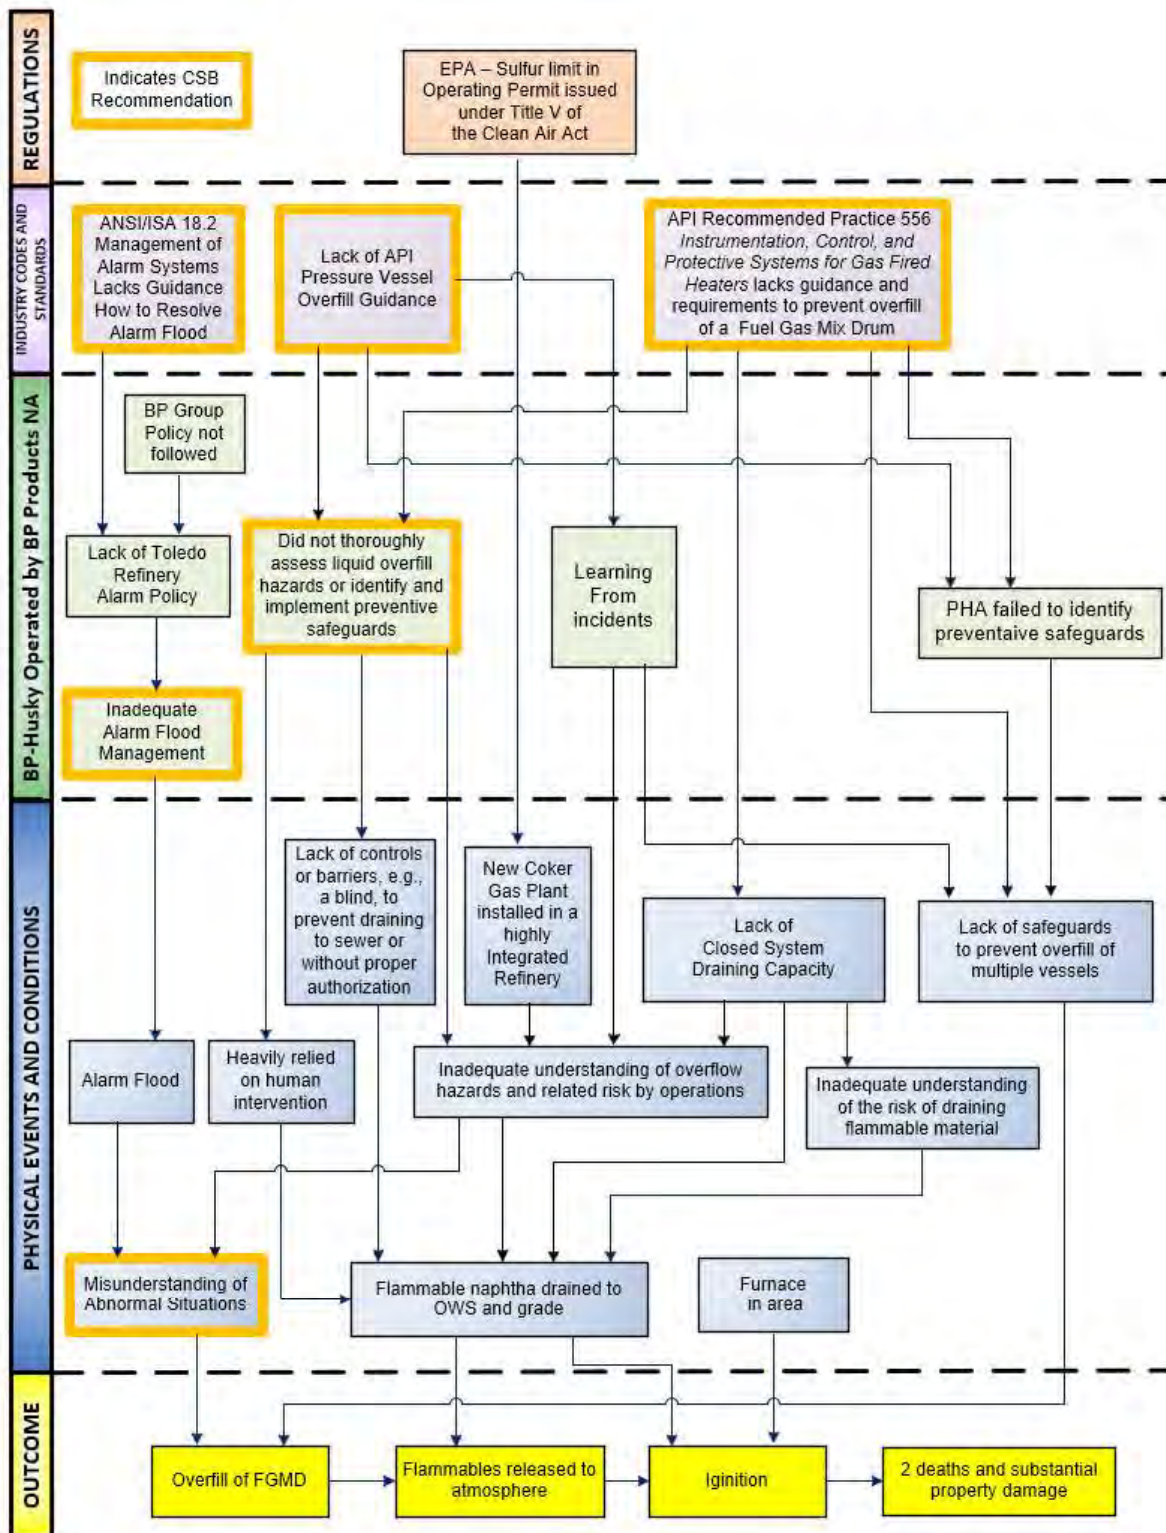
Figure B-1. AcciMap (Credit: CSB)
